Service Bulletin

Bulletin No.: PI0659B

Subject: Groan, Squeak or Rubbing Type Noise When Turning Steering Wheel

Models: 2010-2014 Buick LaCrosse
2012-2014 Buick Regal
2013-2014 Chevrolet Malibu

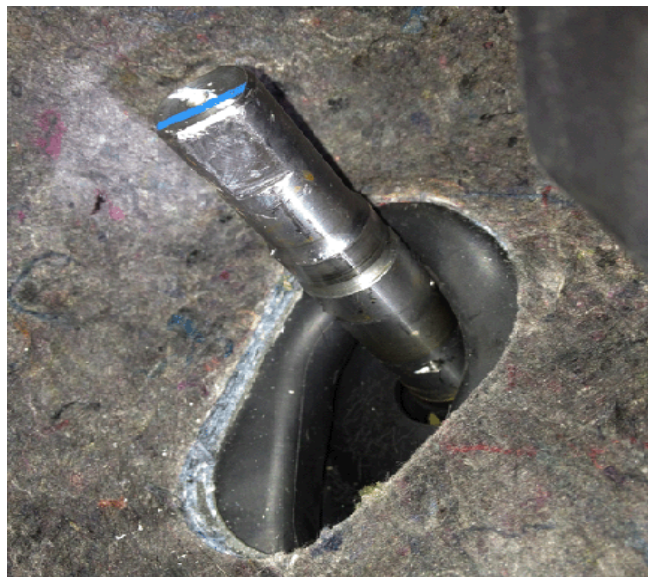
Some customers may comment on a rubber squeak type noise when turning the steering wheel. This condition may be caused by the seal for the intermediate shaft, located at the front of dash, rubbing on the rotating intermediate steering shaft. Refer to the pictures above. On electronic power steering (EPS) equipped vehicles, the EPS wire harness bracket may be contacting the steering column seal.

Technicians should inspect the steering column seal for proper installation by repositioning the inner intermediate steering shaft boot assembly to gain access. Inspect the seal at the front of the dash where the intermediate steering shaft passes through from the steering gear. Ensure that the seal is centered in the opening and around the intermediate steering shaft as shown above. If the seal is out of position, replace the steering column seal following the steps below.
