Service Bulletin

Bulletin No.: PI0746C

Subject: Malfunction Indicator Lamp (MIL) On, Poor Acceleration, Throttle Body Freezing, Multiple DTCs Set, Ice Deposits and/or Oil Deposits Present in Air Inlet Duct

Models: 2008-2011 Buick Enclave
2007-2011 Chevrolet Malibu
2009-2011 Chevrolet Traverse
2007-2011 GMC Acadia
2007-2010 Pontiac G6
2007-2010 Saturn OUTLOOK
Equipped with 3.6L Engine (RPOs LY7, LLT)

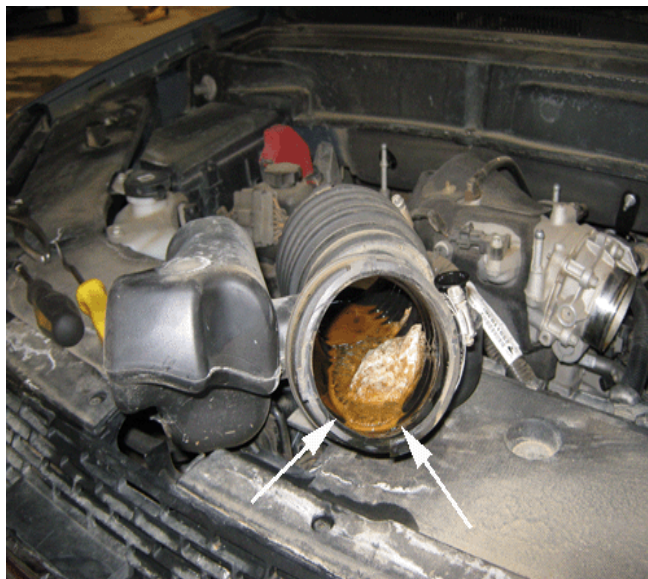
2837688

Technicians may find DTC s P0101, P0171, P0172, P0174, P0175, P1516, P2177, P2178, P2179, P2180, P2187, P2188, P2189 and/or P2190 along with either ice or oil deposits in the air inlet duct.

Ice formation is caused by condensation freezing at the base of the throttle body with additional collection of ice formation deposits in the air inlet duct. Freezing condensation forms after the vehicle has been driven and then parked in low ambient temperatures.

Oil deposits are the collection of the engine vapors, fuel dilution and oil mist at the base of the throttle body with additional formation collecting in the duct.

1. Remove both camshaft covers for servicing of the PCV system. Refer to Camshaft Cover Replacement Left and Right Side in SI.
2. Clean the PCV orifice with low VOC brake cleaner. Allow to air dry with compressed shop air.
3. Replace the bank1 camshaft cover gasket.
4. Reassemble the bank1 camshaft cover.
