Bulletin No.: PI0762C

Service Bulletin

Subject: Coolant Leak at Water Pump

Models: 2011-2012 Chevrolet Cruze
Equipped with 1.4L Turbo Engine (RPO LUJ)

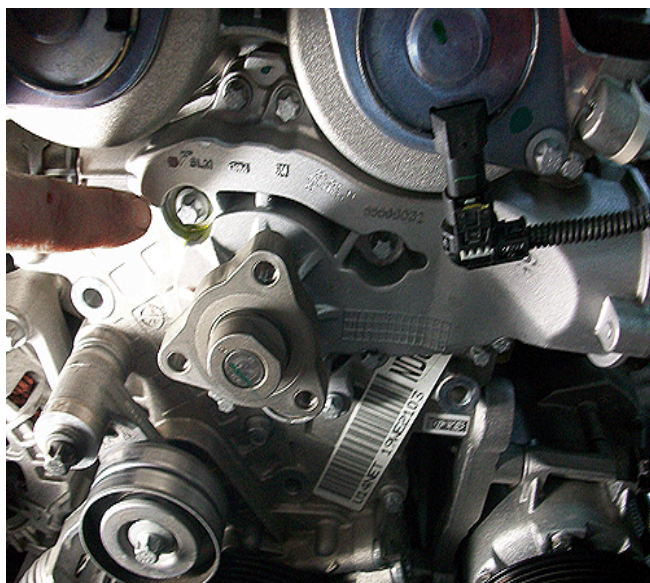
Coolant may be leaking from the water pump mounting bolts.

If the water pump mounting bolts are leaking, do not attempt to tighten or put sealer on the bolts. The water pump and gasket should be replaced.

Important: DO NOT replace the water pump mounting bolts when replacing the water pump.
