# Service Bulletin

Bulletin No.: PI0762D

**Subject:** Coolant Leak at Water Pump

**Models:** 2011-2012 Chevrolet Cruze  
Equipped with 1.4L Turbo Engine (RPO LUJ)

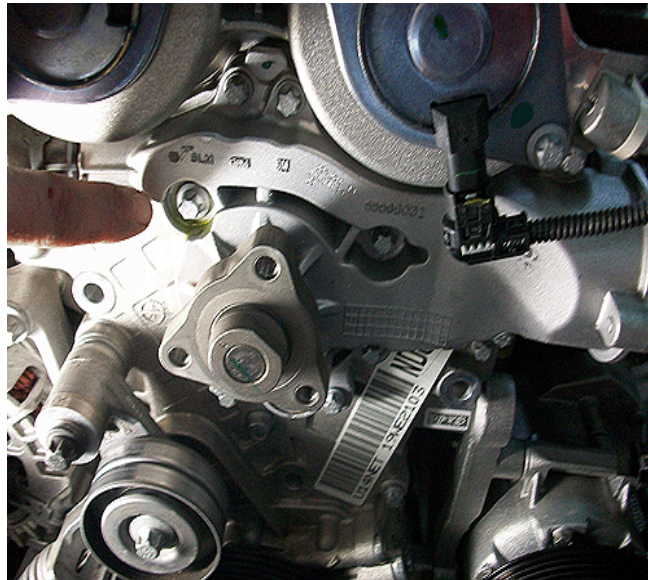
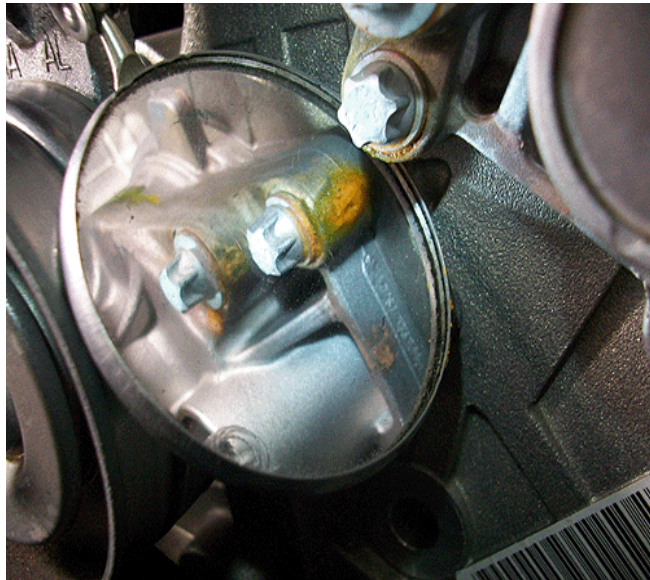
2852126

Coolant may be leaking from the water pump mounting bolts.

If the water pump mounting bolts are leaking, do not attempt to tighten or put sealer on the bolts. The water pump and gasket should be replaced.

**Important:** DO NOT replace the water pump mounting bolts when replacing the water pump.

When replacing the water pump, the thermostat housing seal and engine mount bracket bolts also need to be replaced.
