Service Bulletin

Bulletin No.: PI0430B

Subject: Magnaride™ Magnetically Controlled Suspension Electrical Connector Not Seated, Service Suspension System Message, DTCs C0575, C0580, C0585 or C0590

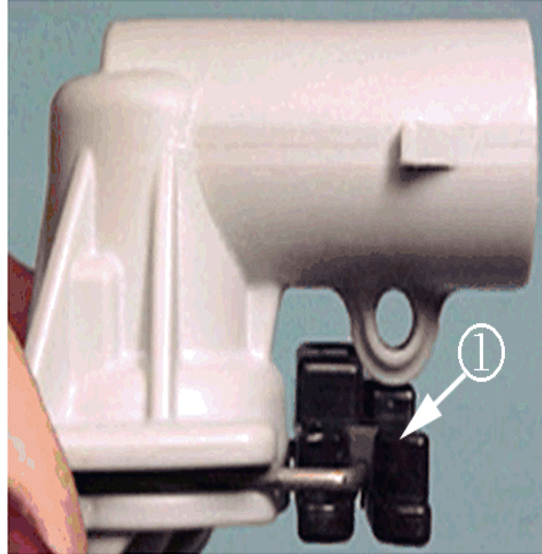
Connector with Position Assurance (CPA) Tab (CTS Only)

CTS Models built after February 22, 2011 have a CPA tab (1) as shown above as part of the connector. Vehicles built with this design should be less susceptible to being unseated. The CTS is the only vehicle to adopt this design change. All other products continue with the original style connector.

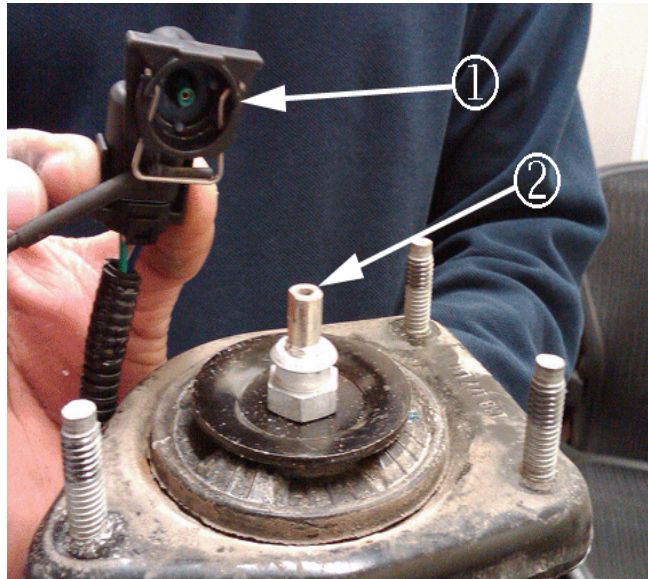
Electrical Connector and Shock Absorber (Actuator) Contact

During the assembly process, it is possible that the 90 degree electrical connector at the top end of a shock absorber (actuator) may not have been fully seated or has been bumped firmly enough to partially disconnect it, or create an internal contact concern.

2. Disconnect the electrical connector (1) from the top of the applicable shock absorber (actuator) contact (2).
