SB-10029104-1378

N54 - Diagnosis of Cold Start Rough Running with Misfire Faults

E82, E88, E89, E90, E92, E93, E60, and E61 vehicles with the N54 engine produced up to 09/2008

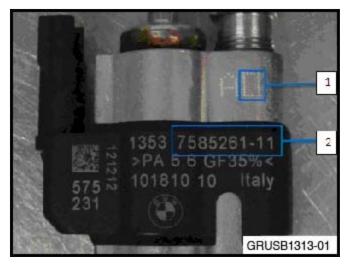
See the photo below to properly identify the index number.

Additional Information: As of January 2013, an improved injector is available. Two distinct markings on the injector itself will identify the improved injector. 1 = Internal material improvement 2 = 7585261 – (index) 11 or greater

IMPORTANT: Injectors with index 11 and higher have a different calibration than injectors with index 10 and lower. Due to this difference, injectors with index 11 and higher and injectors with index 10 and lower cannot be used in the same engine.

If the misfire faults are stored, the complete set of injectors (6) needs to be installed using P/N 13 53 8 616 079 (index 11 or higher).
