SB-10029104-4598

This Service Information bulletin supersedes SI B13 04 09 dated March 2013.

N54 Engine: Diagnosis of Cold Start Rough Running with Misfire Faults

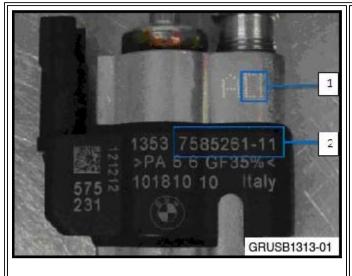
See the photo below to properly identify the index number.

Additional Information: As of January 2013, an improved injector is available. Two distinct markings on the injector itself will identify the improved injector: 1 = Internal material improvement 2 = 7585261 – (index) 11 or greater
