# SB-10029104-9572

This Service Information bulletin supersedes SI B13 04 09 dated January 2011.

N54 Engine: Diagnosis of Cold Start Rough Running with Misfire Faults

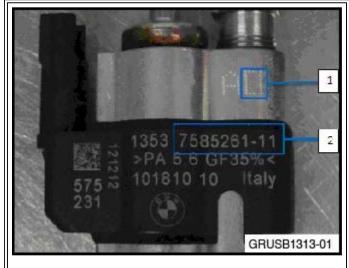
See the photo below to properly identify the index number.

Additional Information:
As of January 2013, an improved injector is available. Two distinct markings on the injector itself will identify the improved injector.

1 = Internal material improvement

2 = 7585261 - (index) 11 or greater

IMPORTANT: Injectors with index 11 and higher have a different calibration than injectors with index 10 and lower. Due to this difference, injectors with index 11 and higher and injectors with index 10 and lower cannot be used in the same engine.

In the case of reproducible "cold start" rough engine running with corresponding misfire faults, replace the high-pressure injectors using improved P/N 13 53 8 616 079 with index 11 or higher. Follow Repair Instruction 13 53 310 for injector removal and installation. Additionally, the spark plugs from the misfiring cylinders which were found to be soaked ("wet") with fuel should be replaced.
