EL03-031c

July 21, 2008

EXTERIOR LAMP FOGGING

APPLIED VEHICLES: 2001-2009 Infiniti, All Models

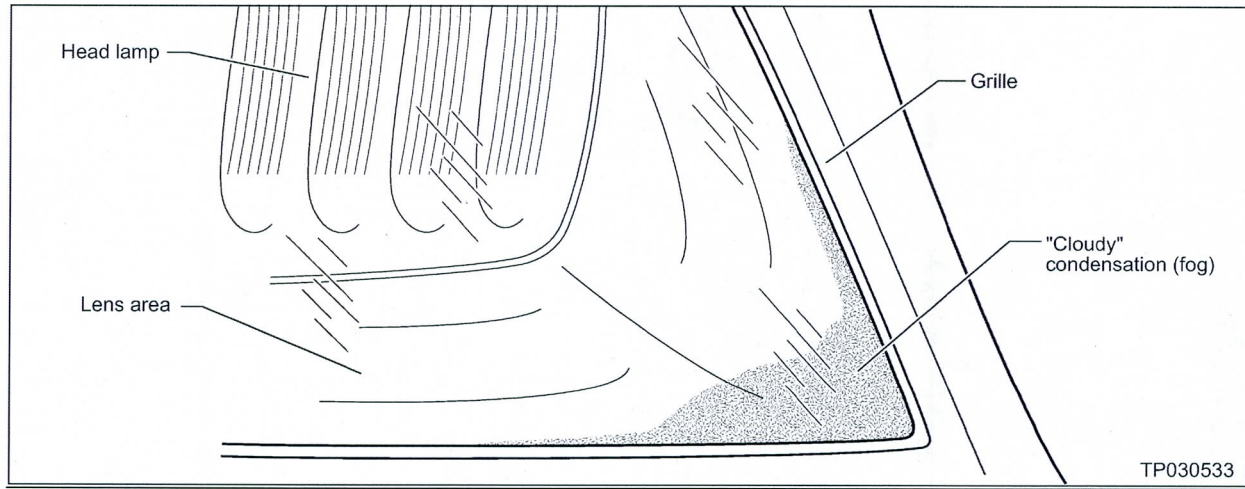
Fog may temporarily form inside the lens of the exterior lights based on environmental conditions or sudden temperature changes, such as a car wash, may cause. This is normal. See Figure 1.

Figure 1: Example of normal condensation, ok

NOTE: This condensation can appear anywhere on the outer lens, typically at its coldest location.

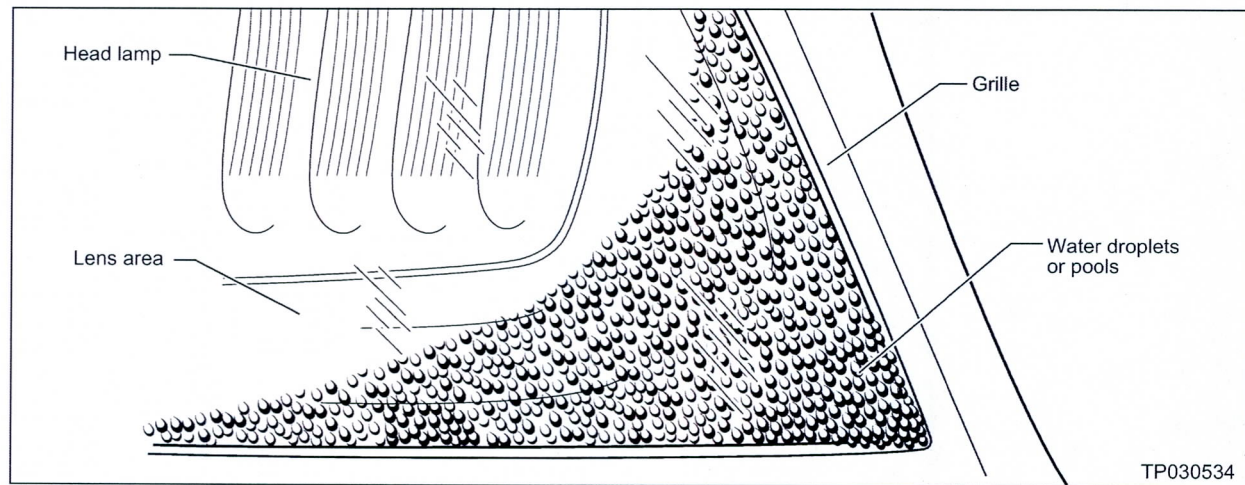
Figure 2: Condition may not be normal

If the moisture trickles, drips, or pools, it may not be considered normal and the headlamp assembly may have a water leak path. See Figure 2 for an example.

If large drops of water collect inside the lens, refer to the flow chart on page 3 to find the next step to take.
