EL03-031g

November 27, 2013

## EXTERIOR LAMP FOGGING

**APPLIED VEHICLES:** 2001-2014 Infiniti, All Models

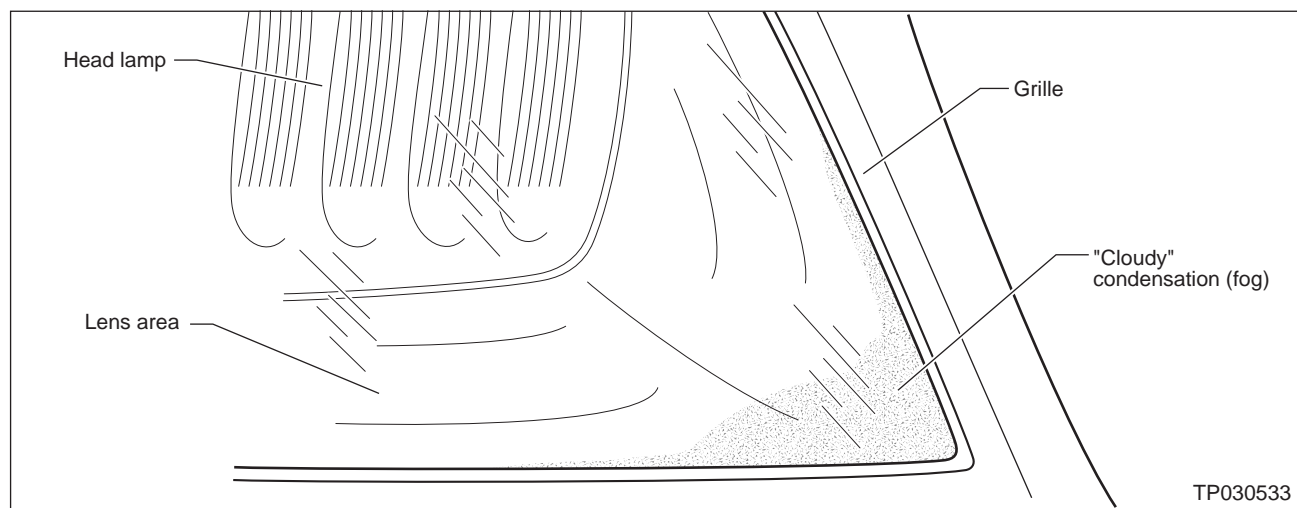
Fog may temporarily form inside the lens of the exterior lamp assemblies based on environmental conditions or sudden temperature changes (such as in a car wash, or parked on a cold, sunny day). This is normal. See Figure 1.

Figure 1: Example of normal condensation, ok

**NOTE:** This condensation can appear anywhere on the outer lens, typically at its coldest location.

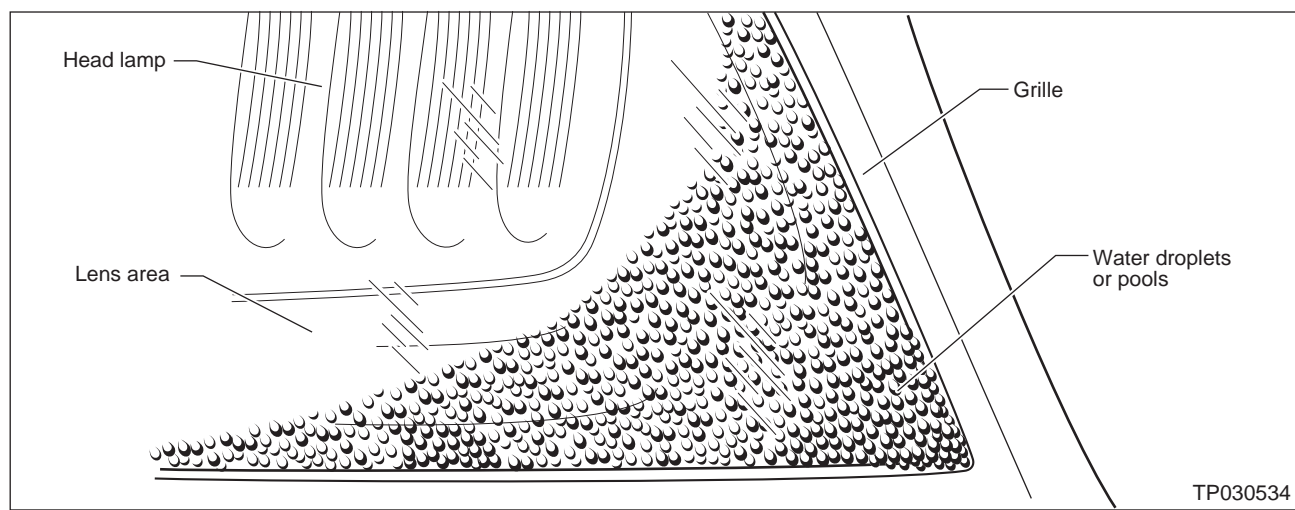
Figure 2: Condition may not be normal

If the moisture trickles, drips, or pools, it may not be considered normal and the headlamp assembly may have a water leak path. See Figure 2 for an example.

If large drops of water collect inside the lens, refer to the flow chart on page 3 to find the next step to take.
