SERVICE BULLETIN

EL03-030e

EXTERIOR LAMP FOGGING

APPLIED VEHICLES: 2001-2010 Nissan, All Models

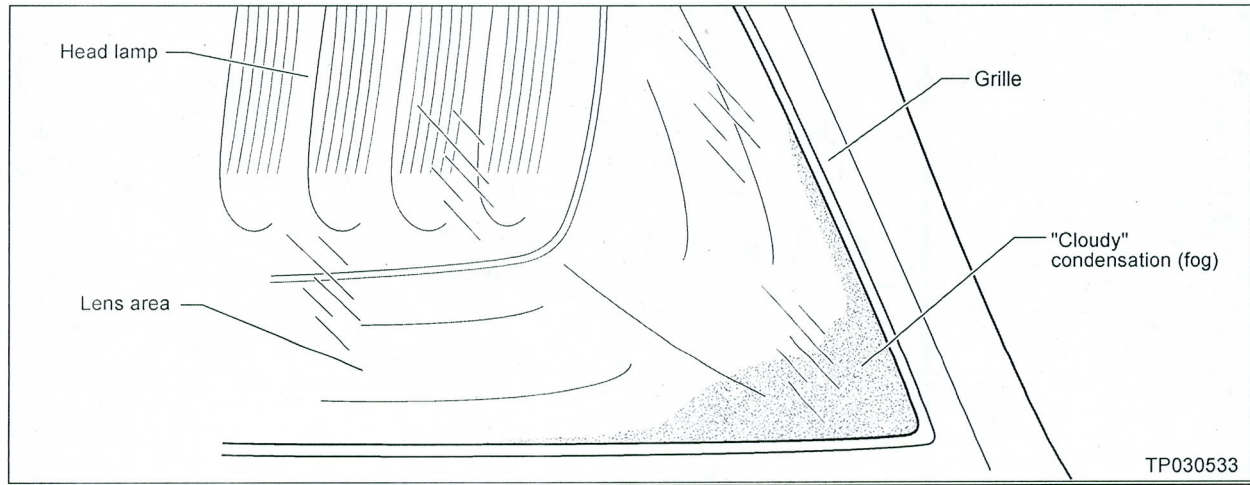
Fog may temporarily form inside the lens of the exterior lights based on environmental conditions or sudden temperature changes (such as in a car wash). This is normal. See Figure 1.

Figure 1: Example of normal condensation, ok

NOTE: This condensation can appear anywhere on the outer lens, typically at its coldest location.

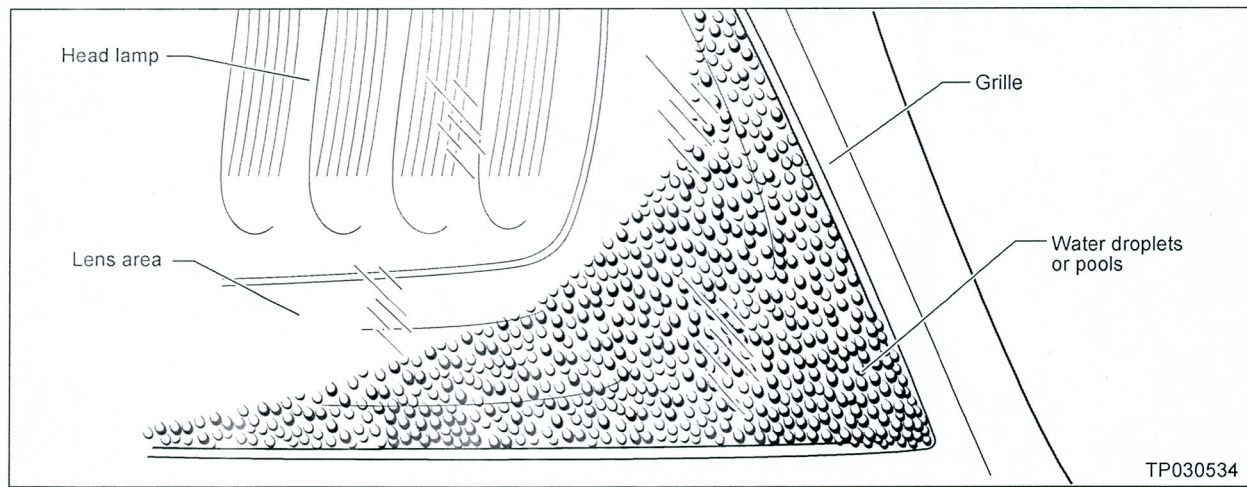
Figure 2: Condition may not be normal

If the moisture trickles, drips, or pools, it may not be considered normal and the lamp assembly may have a water leak path. See Figure 2 for an example.

If large drops of water collect inside the lens, refer to the flow chart on page 3 to find the next step.
