# SERVICE BULLETIN

EL03-030g

November 27, 2013

## EXTERIOR LAMP FOGGING

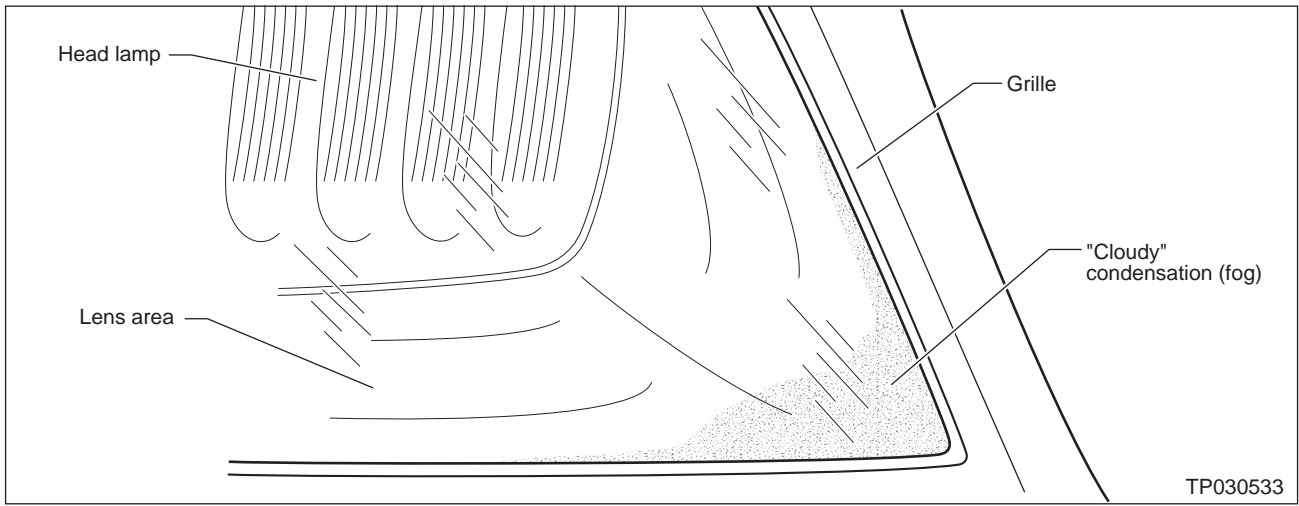
Fog may temporarily form inside the lens of the exterior lamp assemblies based on environmental conditions or sudden temperature changes (such as in a car wash, or parked on a cold, sunny day). This is normal. See Figure 1.

Figure 1: Example of normal condensation, ok

**NOTE:** This condensation can appear anywhere on the outer lens, typically at its coldest location.

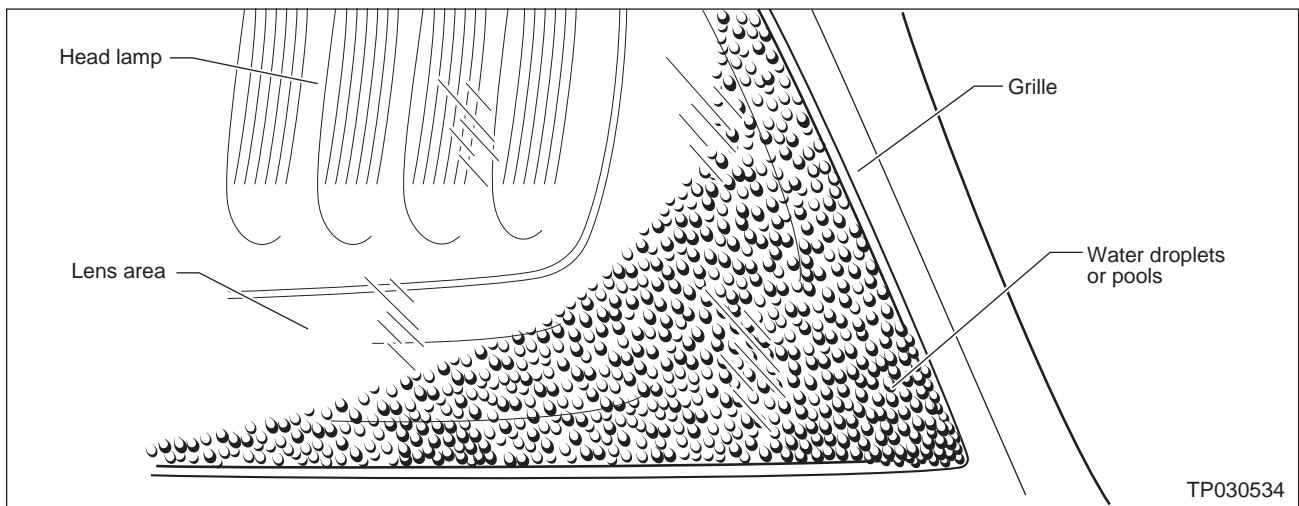
Figure 2: Condition may not be normal

If the moisture trickles, drips, or pools, it may not be considered normal and the lamp assembly may have a water leak path. See Figure 2 for an example.

If large drops of water collect inside the lens, refer to the flow chart on page 3 to find the next step.
