BULLETIN NUMBER:
IB09-J-002

GROUP:
ENGINE

TURBOCHARGER INSPECTION

AFFECTED VEHICLES

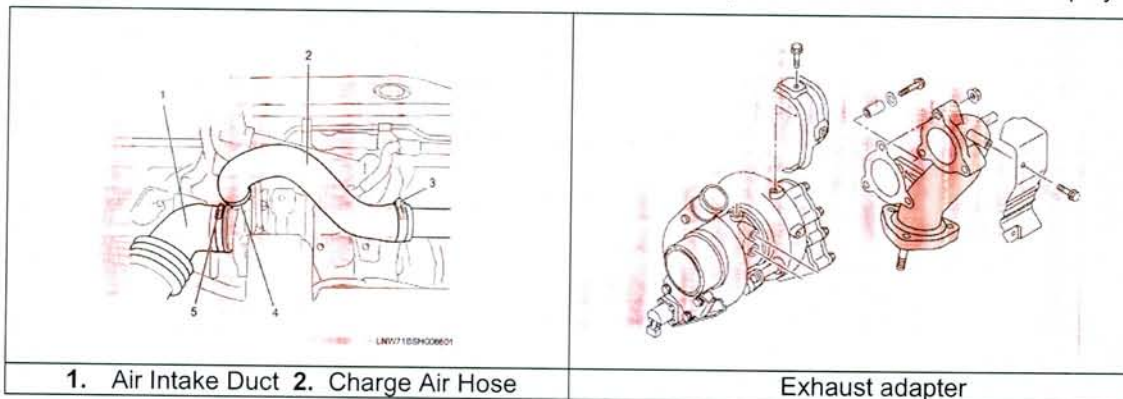
Remove the air intake duct, charge air hose and exhaust adapter from the compressor. Using an inspection light, inspect the compressor and turbine wheels for evidence of foreign object damage. If one or both of the wheels are damaged, a foreign object(s) probably entered through the intake or exhaust system. Identify the origin of the foreign object. Foreign objects usually come from human error or deteriorated engine/intake systems. Repair the source for the foreign object and replace the turbocharger assembly. If **NO** damage is found, inspect the radial and axial shaft play.
