IB09-J-002C

Turbocharger Inspection

2007 - 2010 Chevrolet or GMC W3500/W4500/W5500

2007 - 2014 Isuzu NPR/NPRHD/NQR/NRR

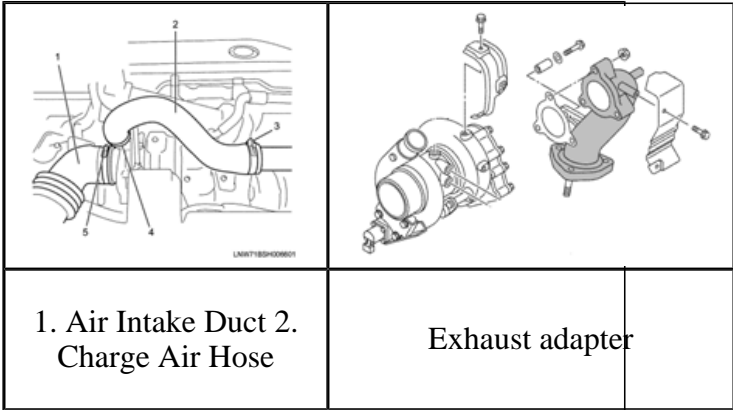
Remove the air intake duct, charge air hose and exhaust adapter from the compressor. Using an inspection light, inspect the compressor and turbine wheels for evidence of foreign object damage. If one or both of the wheels are damaged, a foreign object(s) probably entered through the intake or exhaust system. Identify the origin of the foreign object. Foreign objects usually come from human error or deteriorated engine/intake systems. Repair the source for the foreign object and replace the turbocharger assembly. If NO damage is found, inspect the radial and axial shaft play.

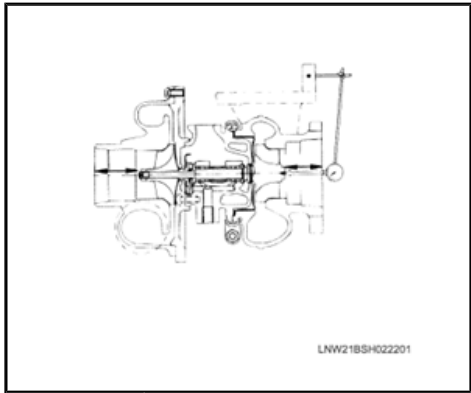
LNW21BSH022201

Spin turbo shaft several times by hand before taking the measurement. Be sure the shaft spins freely. This will remove some excess oil from the bearings which should provide a more accurate measurement. Use a dial gauge to measure the wheel axial shaft play when a force of 12 N (2.6 lb) is alternately applied to both sides of the compressor wheel.

Axle play	Maximum limit mm (in)
4HK1	0.09 (0.0035)
6HK1	0.09 (0.0035)

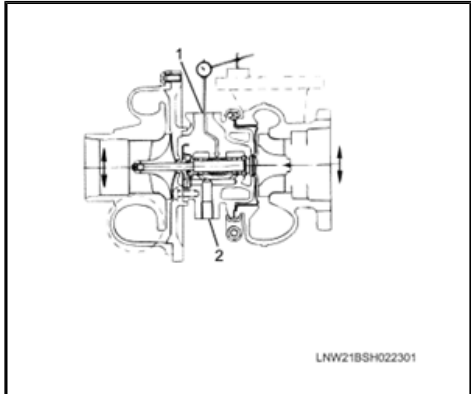
LNW21BSH022301

Use a dial gauge to measure the clearance between the wheel shaft and the bearing. For proper measurement push up and pull down on the turbine and compressor wheels at the same time. Moving only one side or cocking of the shaft can lead to a smaller inaccurate measurement.

Clearance	Maximum limit mm (in)
4HK1	0.17 (0.0067)
6HK1	0.14 (0.0055)
