Technical Bulletin

Section Title: Restraints
TSB No. TS 05 01140R

SUBJECT: COUNTER-MEASURE PROCEDURE FOR DTC B1318
MODEL(S): GRAND VITARA (JB424W/JB632W)
YEAR: 2009
VIN BREAKS: JB424W: ~JS3TD042494101207 May 26, 2009
 JB632W: ~JS3TD148494100441 May 28, 2009

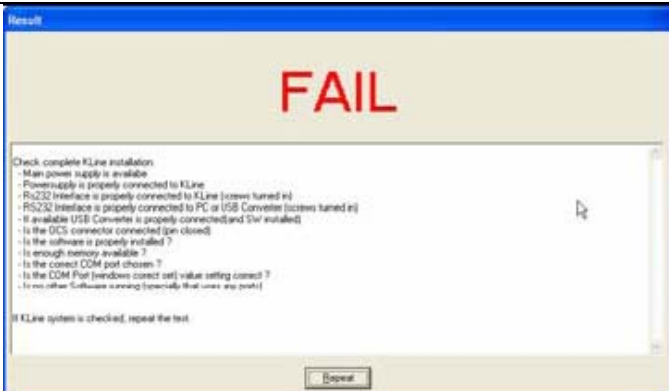
<p>If the “FAIL” window shown to the left has opened, check reprogramming tools, connections, and PC setting by referring to the check list below. Click the “Repeat” button, and retry the reprogramming.</p> <p style="text-align: center;">Note: Reprogramming can be retried twice.</p>

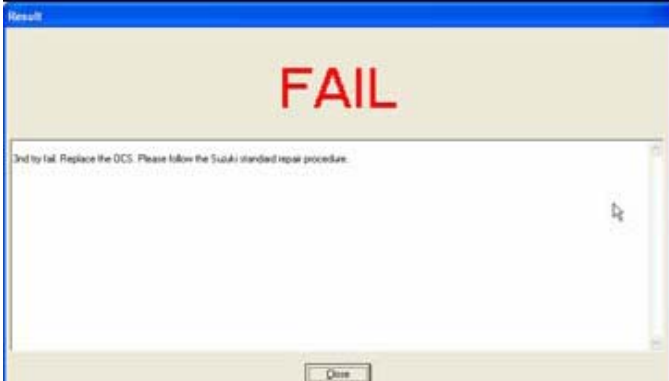
<p>If the “FAIL” window shown to the left has opened, OCS reprogramming is impossible. In most cases the incorrect com port has been set. Recheck the com port settings and make a second attempt to reprogram the OCS. If this “FAIL” screen continues to appear, click the “CLOSE” button and then replace the OCS/Seat Cushion Assembly referring to the service manual.</p>
