SERVICE BULLETIN

AT10-010a

November 5, 2013

2010 ALTIMA, ROGUE, AND SENTRA MIL IS ON AND/OR SLOWER THAN NORMAL ACCELERATION

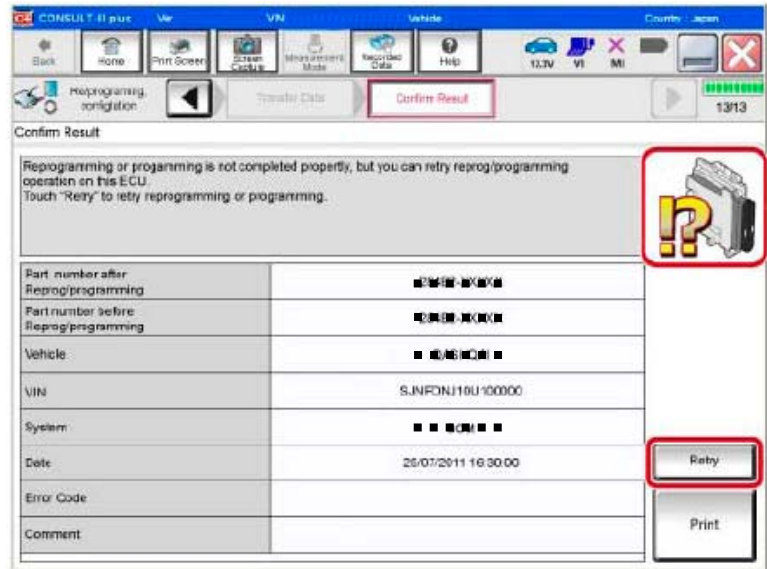
Figure 5

If reprogramming does not complete and the “!?” icon displays as shown in Figure 5:

- Check battery voltage (12.0–15.5 V).
- Ignition is ON, engine OFF.
- External Bluetooth® devices are OFF.
- All electrical loads are OFF.
- **Select retry and follow the on screen instructions.**
- “Retry” may not go through on first attempt and can be selected more than once.

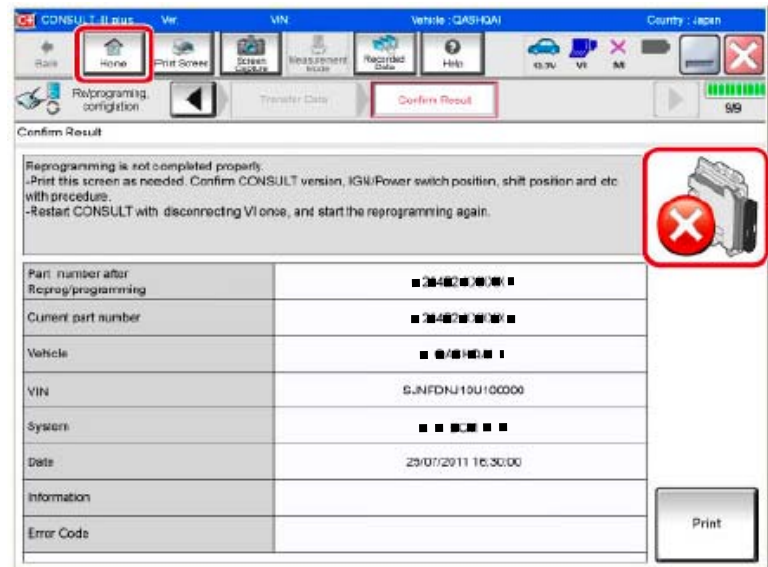
Figure 6

If reprogramming does not complete and the “X” icon displays as shown in Figure 6:

- Check battery voltage (12.0 – 15.5 V).
- CONSULT A/C adapter is plugged in.
- Ignition is ON, engine OFF.
- Transmission is in Park.
- All C-III plus / VI cables are securely connected.
- All C-III plus updates are installed.
- **Select Home, and restart the reprogram procedure from the beginning.**
