Applies To: **2009–11 Pilot** – See VEHICLES AFFECTED

August 26, 2010

**Product Update: Parasitic Current Draw From Moonroof Control Unit Can Discharge the Battery, and/or Moonroof Reverses Itself While Closing**  
 (Supersedes 10-030, dated July 27, 2010, to revise the information marked by the black bars)

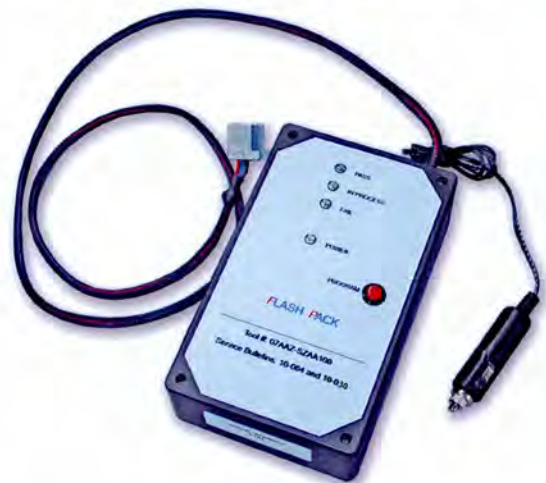
Flash Pack: P/N 07AAZ-SZAA100

Each dealer was sent one Flash Pack in July 2010. *This tool's only use is for updating the software on moonroof control units in 2009–11 Pilots.*

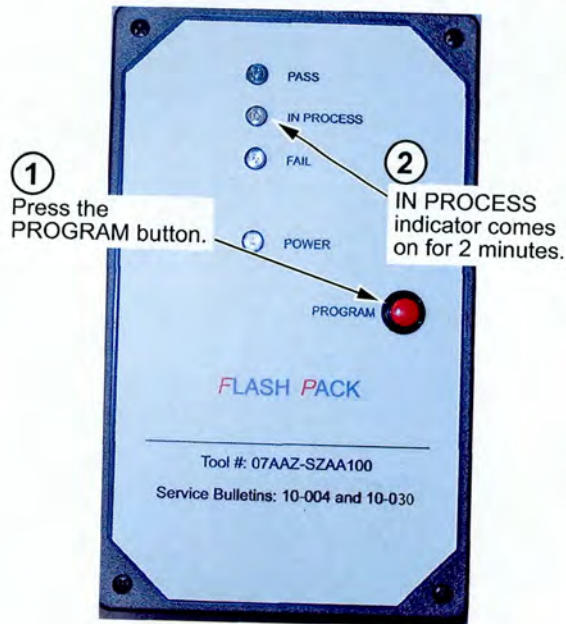
NOTE: If the red FAIL indicator comes on during the update, press the PROGRAM button again. If the FAIL indicator comes on again, the moonroof control unit (motor) needs to be replaced.

- Press the **PROGRAM** button on the Flash Pack. The yellow IN PROCESS indicator stays on for about 2 minutes, then the green PASS indicator comes on to let you know the software update is completed.
