Applies To: **2009–11 Pilot** – Check the iN VIN Status for eligibility

Product Update: Parasitic Current Draw From Moonroof Control Unit Can Discharge the Battery

(Supersedes 10-030, *Product Update: Parasitic Current Draw From Moonroof Control Unit Can Discharge the Battery and/or Moonroof Reverses Itself While Closing*, dated August 26, 2010, to revise the information marked by the black bars)

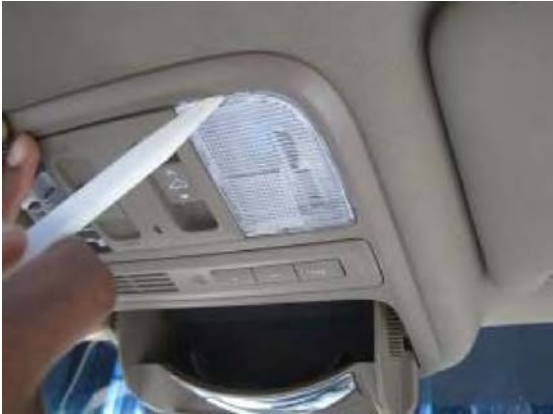
1. Using a trim tool, remove the map light lenses from the roof console.

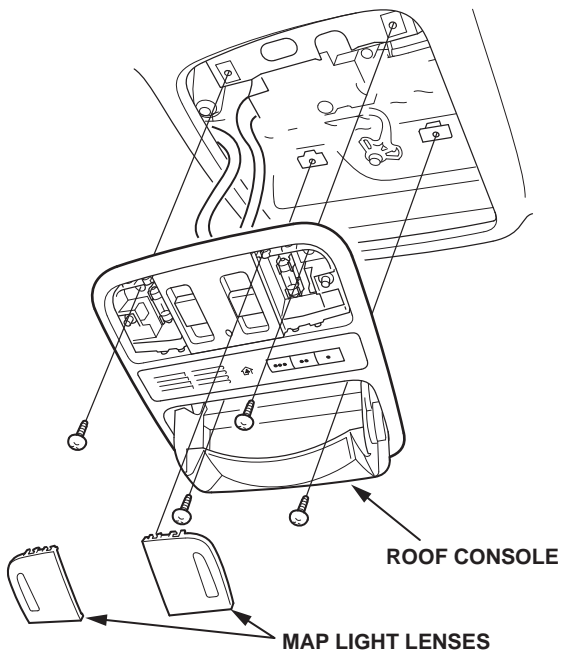
2. Remove the four screws from the roof console, then remove the console from the roof. You don't need to disconnect the wire harness connectors; just let the console hang.

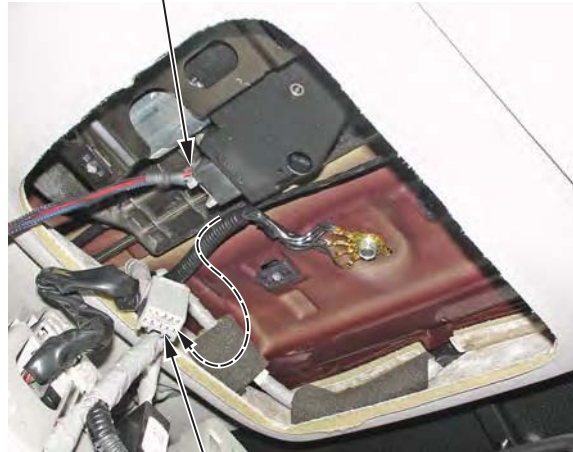
FLASH PACK 10P CONNECTOR

Disconnect the moonroof control unit 10P connector.

4. Connect the Flash Pack power connector to the vehicle's 12 V power outlet. The blue POWER indicator on the Flash Pack comes on.
5. Disconnect the moonroof control unit 10P connector, then connect the Flash Pack 10P connector to the control unit.

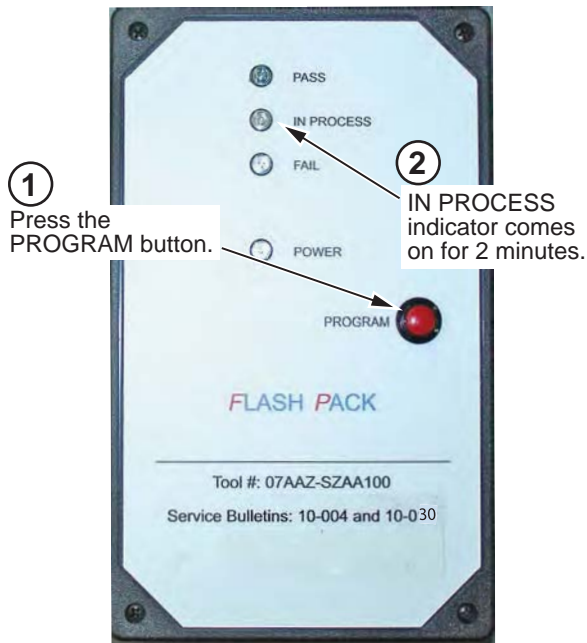
- Press the **PROGRAM** button on the Flash Pack. The yellow IN PROCESS indicator stays on for about 2 minutes, then the green PASS indicator comes on to let you know the software update is completed.

NOTE: If the red FAIL indicator comes on during the update, press the PROGRAM button again. If the FAIL indicator comes on again, the moonroof control unit (motor) needs to be replaced.

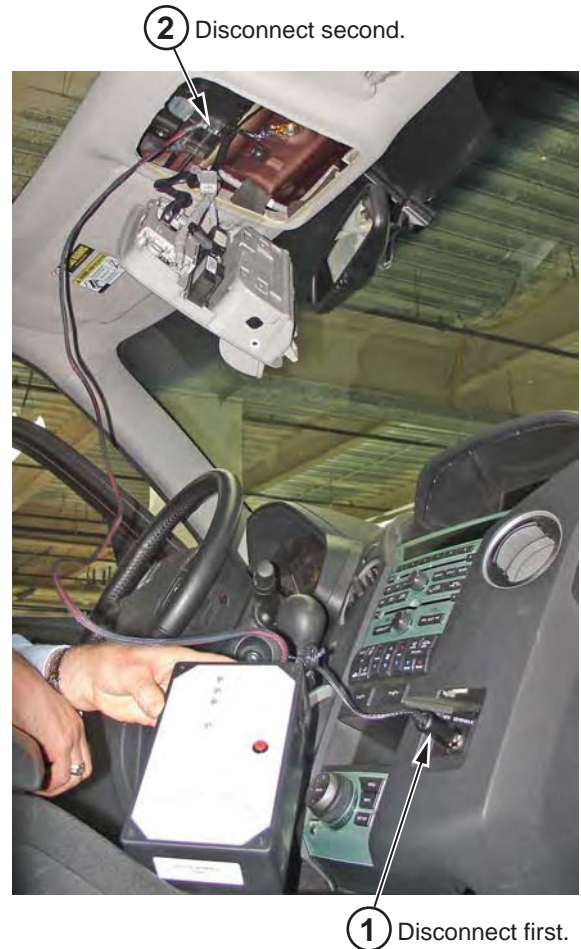
- With the engine still running, disconnect the Flash Pack power connector from the 12 V power outlet, then disconnect the Flash Pack 10P connector from the moonroof control unit, in that order.
