Service Bulletin

Bulletin No.: PI0310B

Subject: Loss of Communication with Allison Transmission Control Module (TCM), Intermittent Transmission Hesitation, Reduced Torque, Range Inhibit, Clunk, Stuck in Gear or in Neutral, Won't Shift, DTC P0880 and/or U0101 Set (Inspect for Electrostatic Discharge (ESD) From Aftermarket Serpentine Belts and/or Added Equipment, Install OEM Belt, Relocate TCM)

Models: 2007-2012 Chevrolet Silverado
2007-2012 GMC Sierra
Equipped with Allison® A1000 Automatic Transmission RPO MW7

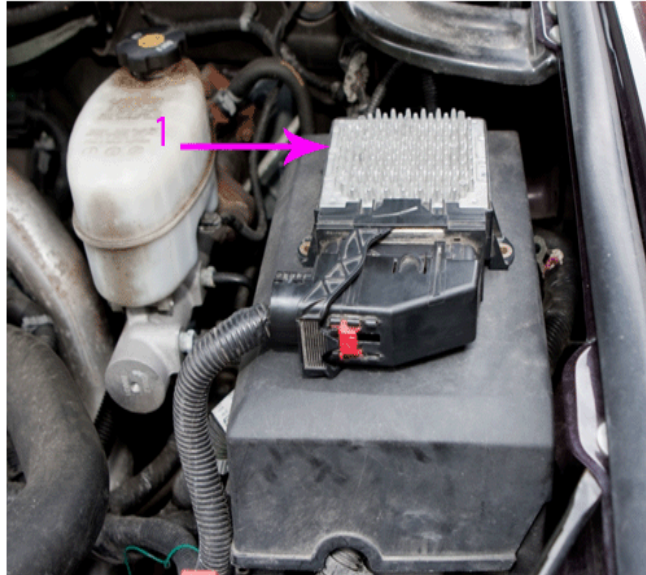
2544173

Relocate the TCM ONLY if an additional or longer accessory drive belt has been installed on the engine, resulting in the drive belt being closer to the TCM.

6. Relocate the TCM (1) to the top of the UBEC cover and secure it using a heavy duty adhesive or Velcro® “hook and loop fastener”. DO NOT use push pins as fasteners, they will compromise the water resistance of the UBEC cover.
