**Subject:** Loss of Communication with Allison Transmission Control Module (TCM), Intermittent Transmission Hesitation, Reduced Torque, Range Inhibit, Clunk, Stuck in Gear or in Neutral, Won't Shift, DTC P0880 and/or U0101 Set (Inspect for Electrostatic Discharge (ESD) From Aftermarket Serpentine Belts and/or Added Equipment, Install OEM Belt, Relocate TCM)

**Models:** 2007-2012 Chevrolet Silverado  
2007-2012 GMC Sierra  
Equipped with Allison® A1000 Automatic Transmission RPO MW7

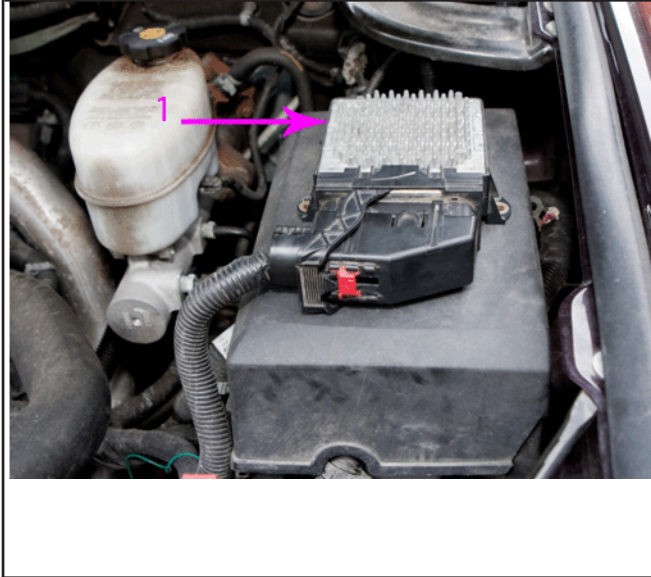
2544173

**Important:** DO NOT relocate the transmission control module (TCM) if aftermarket equipment HAS NOT been installed on the engine.

Relocate the TCM ONLY if an additional or longer accessory drive belt has been installed on the engine, resulting in the drive belt being closer to the TCM.

Relocating the TCM on a vehicle that has not been modified, WILL NOT correct the DTCs and may result in a comeback.

4. Relocate the TCM (1) to the top of the UBEC cover and secure it using a heavy duty adhesive or Velcro® "hook and loop fastener". DO NOT use push pins as fasteners, they will compromise the water resistance of the UBEC cover.
