SERVICE BULLETIN

Classification: AT10-009a	Reference: NTB11-002a	Date: February 21, 2011
------------------------------	--------------------------	----------------------------

2010 MAXIMA, MURANO, & V-6 ALTIMA; MIL IS ON AND / OR SLOWER-THAN-NORMAL ACCELERATION

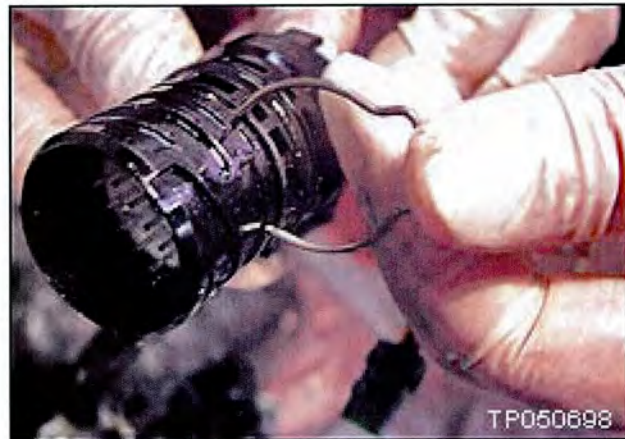
Figure 5

- Black CVT harness connector and lock ring shown removed from the transmission case (see Figure 5).

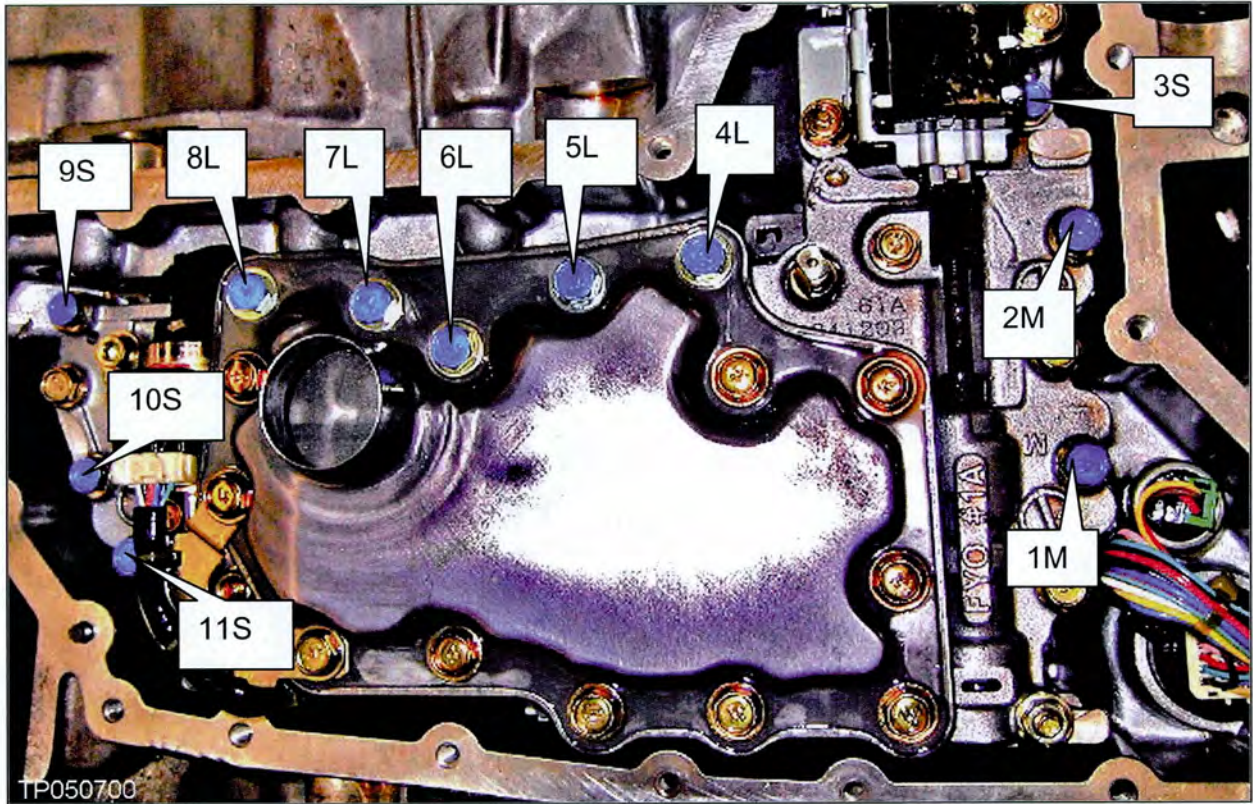
- There are eleven (11) bolts shown and numbered for convenience.
- There are three (3) different length bolts which are identified by:
S-short
M-medium
L-long

13. Remove the bolts attaching the valve body to the transmission (see Figure 7).

- Make sure the different lengths of bolts are installed in the correct holes (see Page 7, Figure 7).

- Tightening torque: 6.9-8.9 N•m (0.7-0.9 kg-m, **61.1-78.8 in-lb**) *.
- Torque sequence as per Figure 7, Page 7: 6-7-5-8-4-9-3-10-2-11-1.
- Refer to Figure 7 for bolt numbering and position.
