| Topic | Service info: Gas discharge headlamp - lens flare |
| Brand | Bentley |
| Transaction No. | 2025611/1 |

## New Continental GT

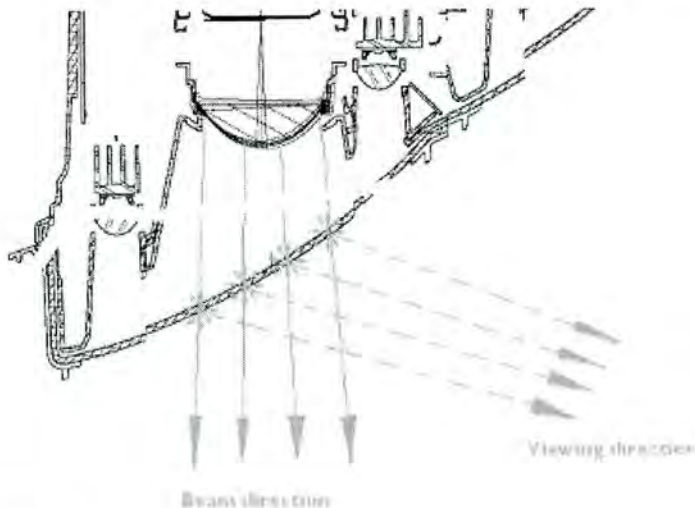
Figure 1

When the projector is lit on a Gas Discharge Headlamp unit and the headlamp is viewed obliquely, a lit patch may be visible on the headlamp lens (see Figure 1).

This is normal and can be seen on all plastic-lensed Gas Discharge Headlamps.

What is seen is the high-intensity light diffused by the normally occurring microscopic flaws in the lens material. These are a combination of flaws in the polycarbonate surface, the mandatory hard coating and predominately, diffusion within the polycarbonate material itself.

Since the phenomenon is a consequence of the inherent properties of the materials, there is no possibility of eliminating it
