**SB-10038194-5423**

| Topic | Service info: Gas discharge headlamp - lens flare |
| Brand | Bentley |

### 2012 onwards-Continental GT derivatives and Flying Spur

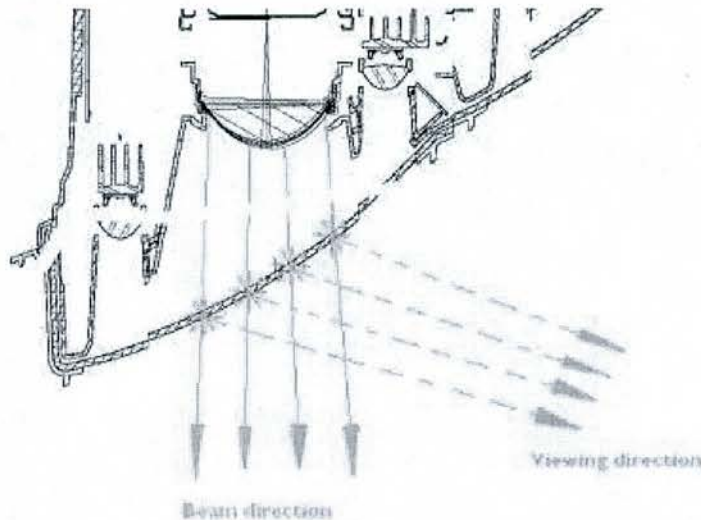
Figure 1

Light patch visible on the front of headlamp lenses when switched on looks like misting or fogging

When the projector is lit on a Gas Discharge Headlamp unit and the headlamp is viewed obliquely, a lit patch may be visible on the headlamp lens (see Figure 1).

This is normal and can be seen on all plastic-lensed Gas Discharge Headlamps.

What is seen is the high-intensity light diffused by the normally occurring microscopic flaws in the lens material. These are a combination of flaws in the polycarbonate surface, the mandatory hard coating and predominately, diffusion within the polycarbonate material itself.

Since the phenomenon is a consequence of the inherent properties of the materials, there is no possibility of eliminating it
