## VOLKSWAGEN DEALERSHIP COMMUNICATION

Subject: Service Action 97U3 – Mailing Wave 1 of 3

Inspect Front Seat Side Impact Airbag Connectors & Install Wiring Harness Kit(s) if Necessary

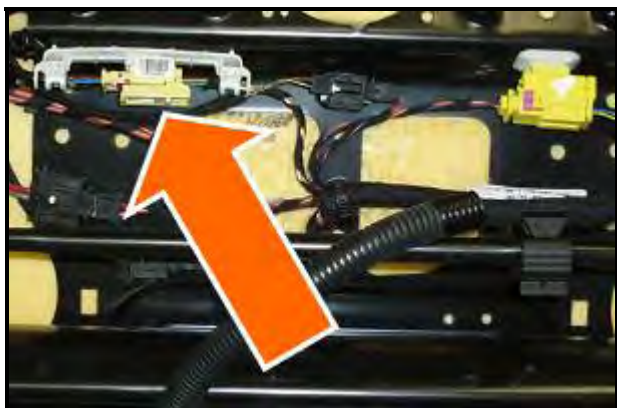
Tip: The Yazaki connector –arrow- may or may not be contained in holder as pictured

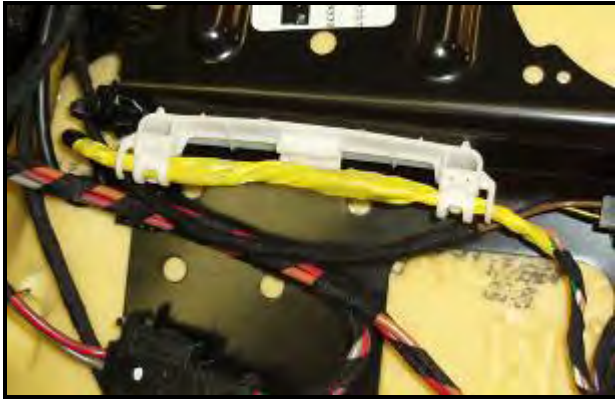
⇐ If Yazaki connector (previous picture) has been removed and seat wiring harness repaired as pictured, Work Complete for that seat, reposition seat to customer original setting(s)
