SI B63 10 09
Lights

March 2013
Technical Service

Brake Light Bulb Failure

MODEL

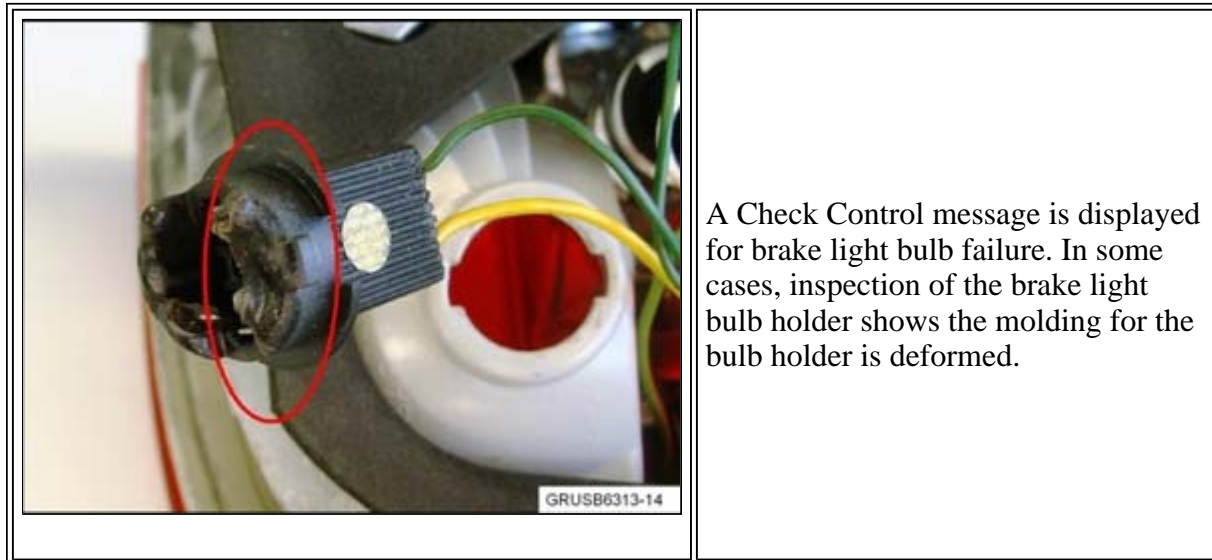
A Check Control message is displayed for brake light bulb failure. In some cases, inspection of the brake light bulb holder shows the molding for the bulb holder is deformed.

- Composition of the bulb holder material and high bulb temperatures
- Premature bulb failure
- Coding error in FRM (Footwell Module)
- Non-approved accessories or non-original parts (for example, aftermarket trail hitch or light bulbs)

2. Inspect the light bulb holder. If the bulb holder is black and damaged, it must be replaced with a new bulb holder (gray color with harness included). Replace the failed bulb with a long-life bulb 12V/16W (1 pair per side).

Note: If the lamp body is deformed and the installation of the bulb holder or the new socket is affected, replace the complete lamp assembly instead of the bulb holder.
