Missing Bolts (Rear Engine Mount and Frame)

GU

PI0751, Missing Bolts (Rear Engine Mount and Frame)

(July 2011)

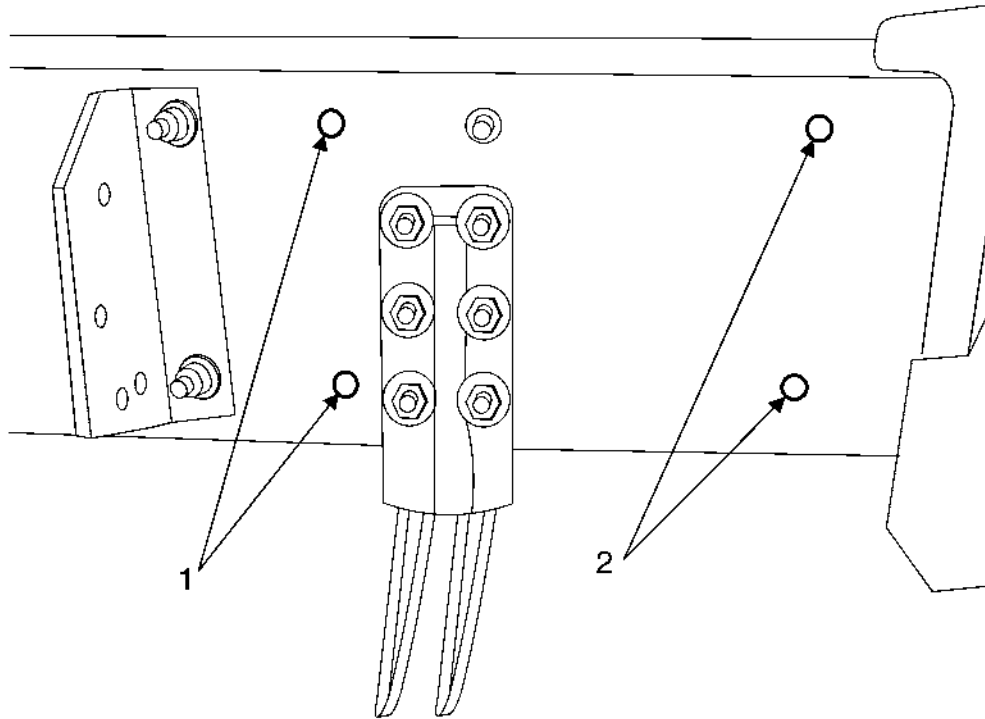
W2066620

Certain GU chassis' have been identified as having four fasteners left out during assembly. Two of the fasteners go through the right side rear engine support and frame and the other two go into unused holes in the right frame forward of the engine support.

- 1 Missing Engine Support Bolt Locations
- 2 Missing Frame Bolt Locations
- 4 Install Hex Bolt (part number 980060) through the unused holes in the frame and secure with hex bolt nut (part number 969306). Torque to 175 Nm (130 ft-lb).
- 5 Install all previously removed cables to the ground (negative) battery terminals.

- 3 Install Hex Bolt (part number 975210) into the open holes on the RIGHT REAR engine support. Secure with hex bolt nut (part number 979231). Torque to 175 Nm (130 ft-lb).
