ITB11-041c

**VOLUNTARY SERVICE CAMPAIGN  
1997-2003 QX4 IN NON SALT STATES  
LEFT FRONT STRUT HOUSING CORROSION**

CAMPAIGN ID #: R1110  
NHTSA #: 11V-244  
APPLIED VEHICLES: 1997- 2003 QX4 (JR50)

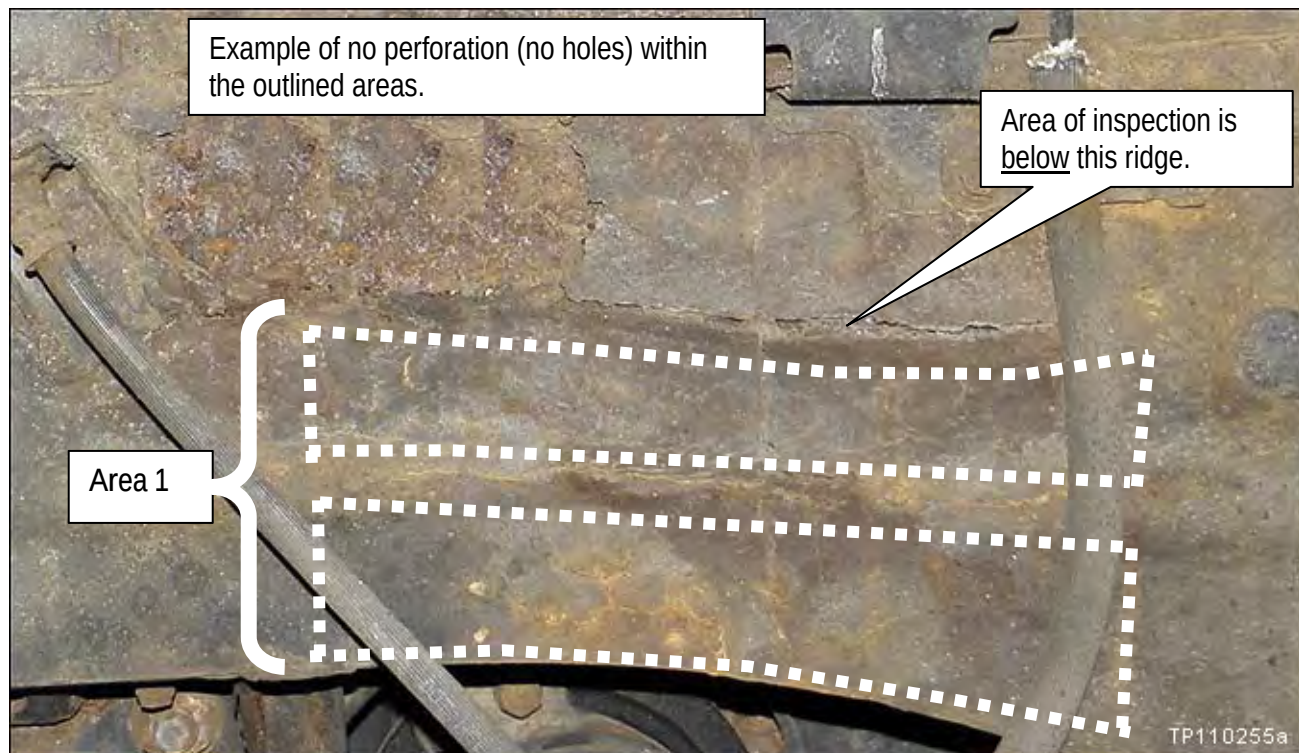
Figure 3

Area 1: Look for perforation (holes) in the metal only in the areas outlined above.

- Retain the vehicle at the dealer. (The vehicle is not repairable.)
- Supply the customer with a rental car.
- Fax a completed Non-Repairable Report to Morley (see page 55).

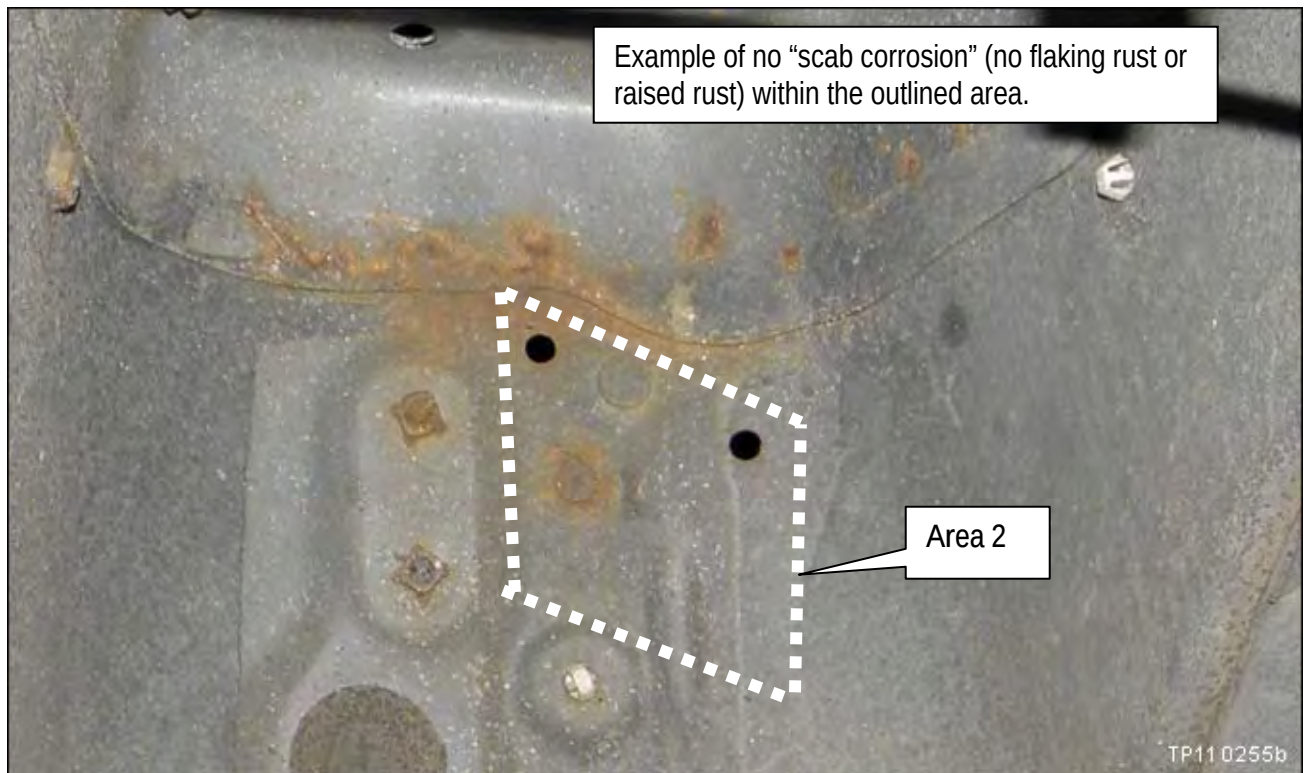
Figure 4

Area 2: Look for “scab corrosion” (flaking rust or raised rust) only in the area outlined above.

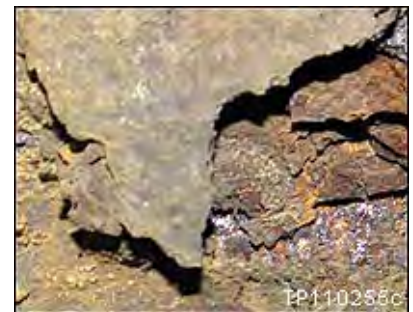
Figure 5 is an example of “scab corrosion” (flaking and raised rust).

- Retain the vehicle at the dealer. (The vehicle is not repairable.)
- Supply the customer with a rental car.
- Fax a completed Non-Repairable Report to Morley (see page 55).

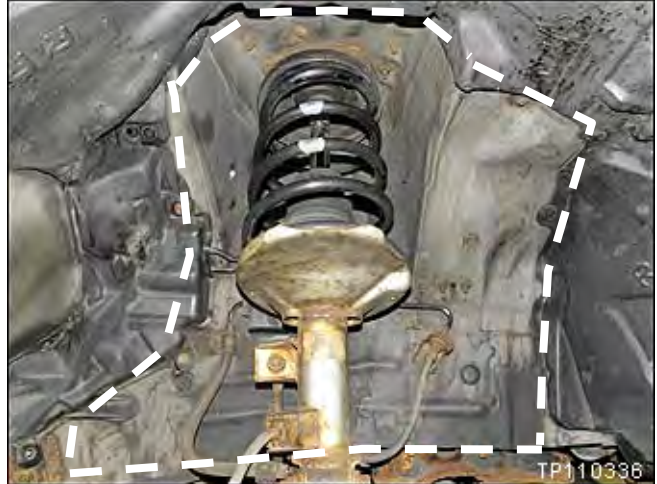
Figure PS4

- This repair is used only if there is metal perforation on the passenger side in the area show in Figure PS4.
- If there is no perforation, go to Level 1 repair on page 38.
- Plastic covers (fender protectors) in the wheel house area do not need to be removed.
- For 4WD vehicles: If the drive shaft boot is ripped, it should be covered to prevent debris from entering the drive shaft joint.

5. Cut a piece of fiberglass cloth to cover at least 1 inch beyond the perforation on all sides.
  - If there is more than one perforation, cut fiberglass cloth for each perforated area.
  - Use 3M™ Bondo Fiberglass Repair Kit (P/N 422) or equivalent.
  - Use protective gloves (such as rubber gloves or disposable gloves) while working with fiberglass and resin.
6. Apply fiberglass patch to the perforated area.
  - No additional surface preparation is needed.
    - Apply patch over the self etching primer.
    - Cleaning/grinding to bare metal is not needed.
  - Use protective gloves (such as rubber gloves or disposable gloves) while working with fiberglass and resin.
  - Follow all warnings and cautions for the fiberglass product being used.
  - Follow the product instructions for applying the fiberglass patch.

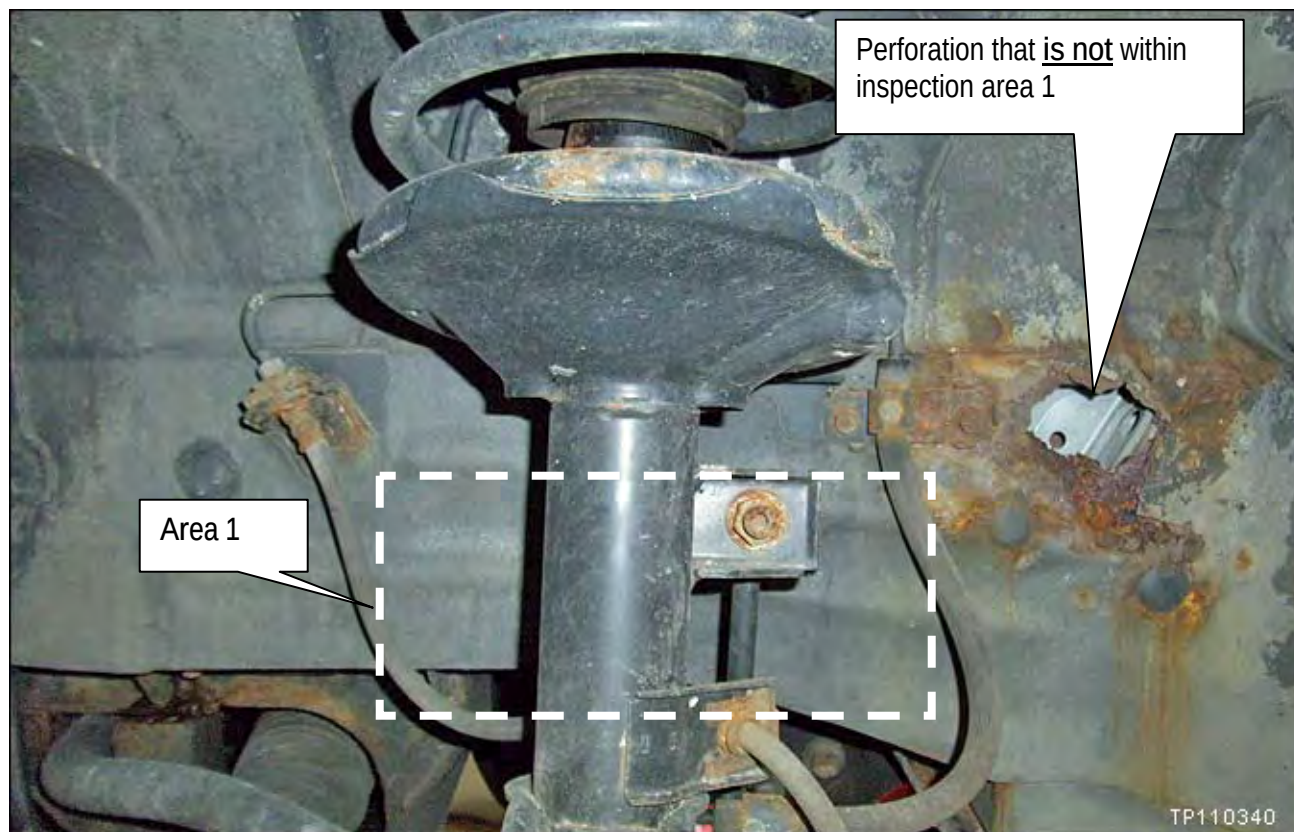
### Examples (Additional Photos) of Area 1 Perforation Inspection

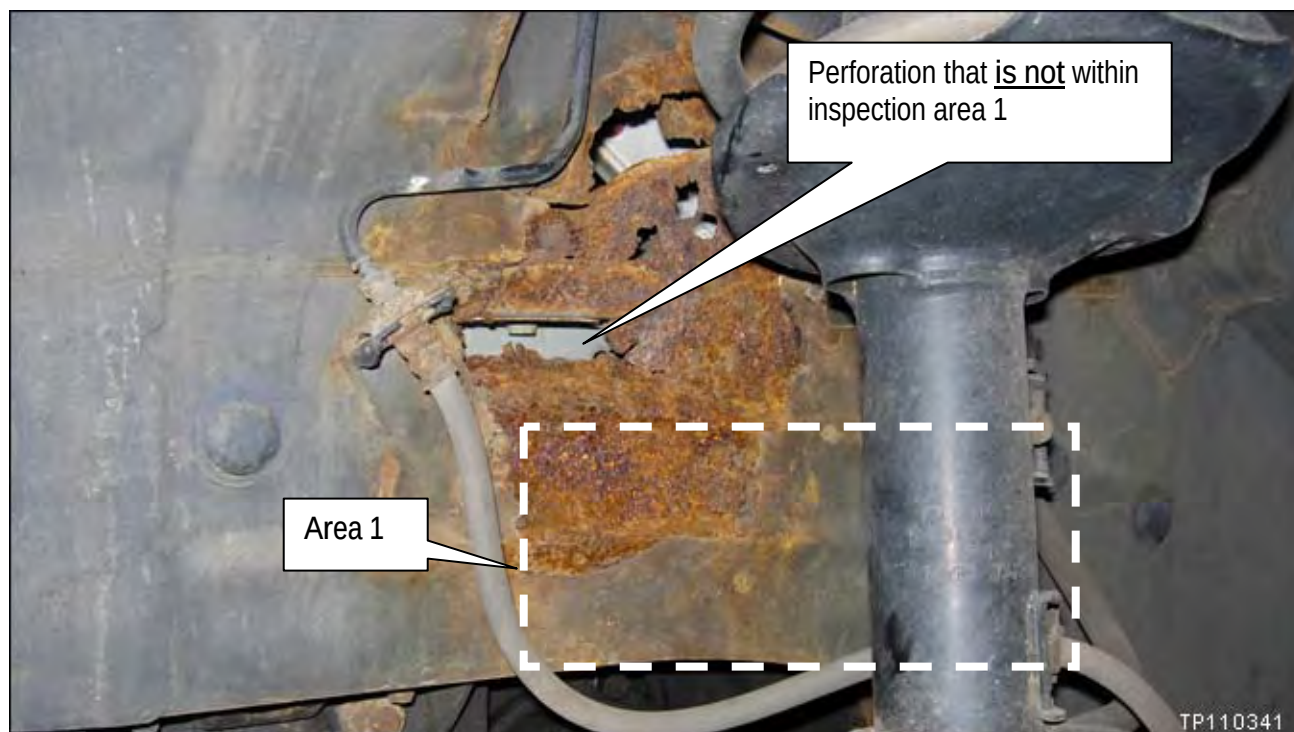
### Example (Additional Photo) of Area 1 Perforation Inspection

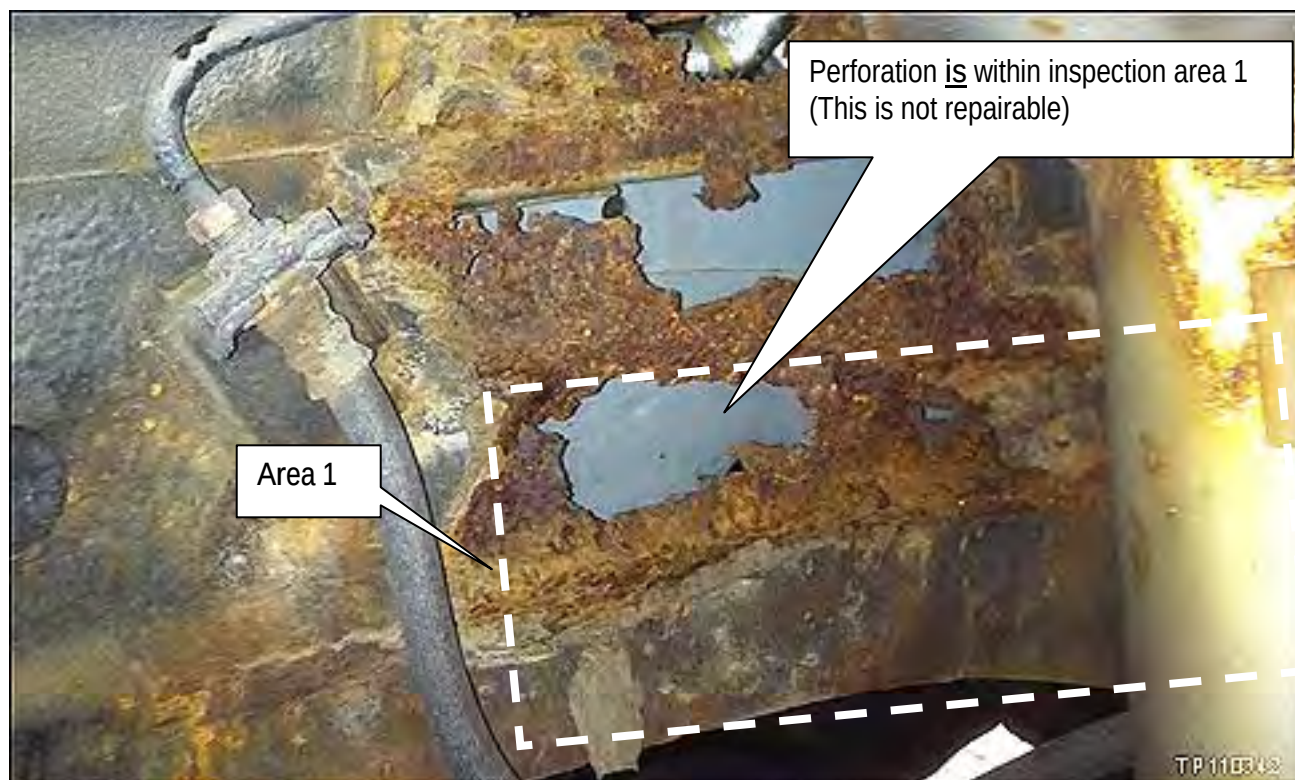
Example (Additional Photo) of Area 1 Perforation Inspection

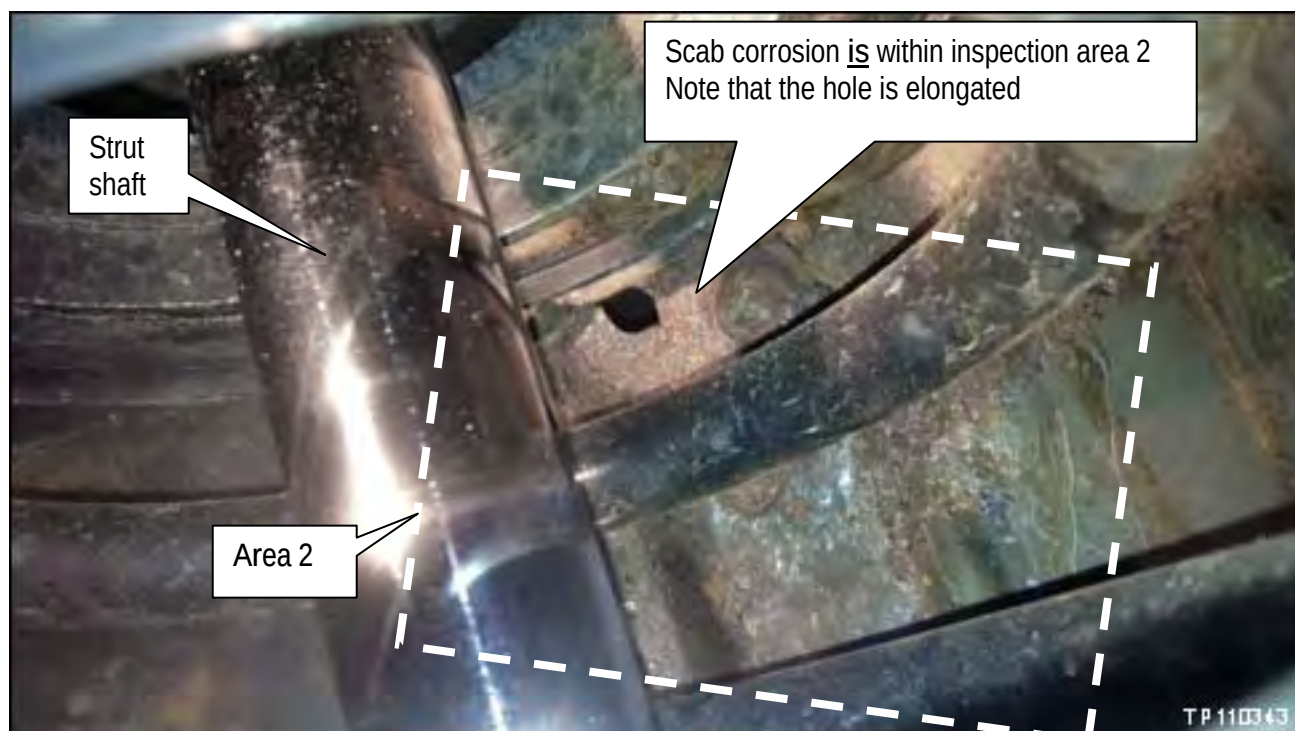
Example (Additional Photo) of Area 2 Scab Corrosion Inspection
