ITB11-041a

September 1, 2011

**VOLUNTARY SERVICE CAMPAIGN  
1997- 2003 QX4 IN NON SALT STATES  
LEFT FRONT STRUT HOUSING CORROSION**

CAMPAIGN ID #: R1110  
NHTSA #: 11V-244  
APPLIED VEHICLES: 1997- 2003 QX4 (JR50)

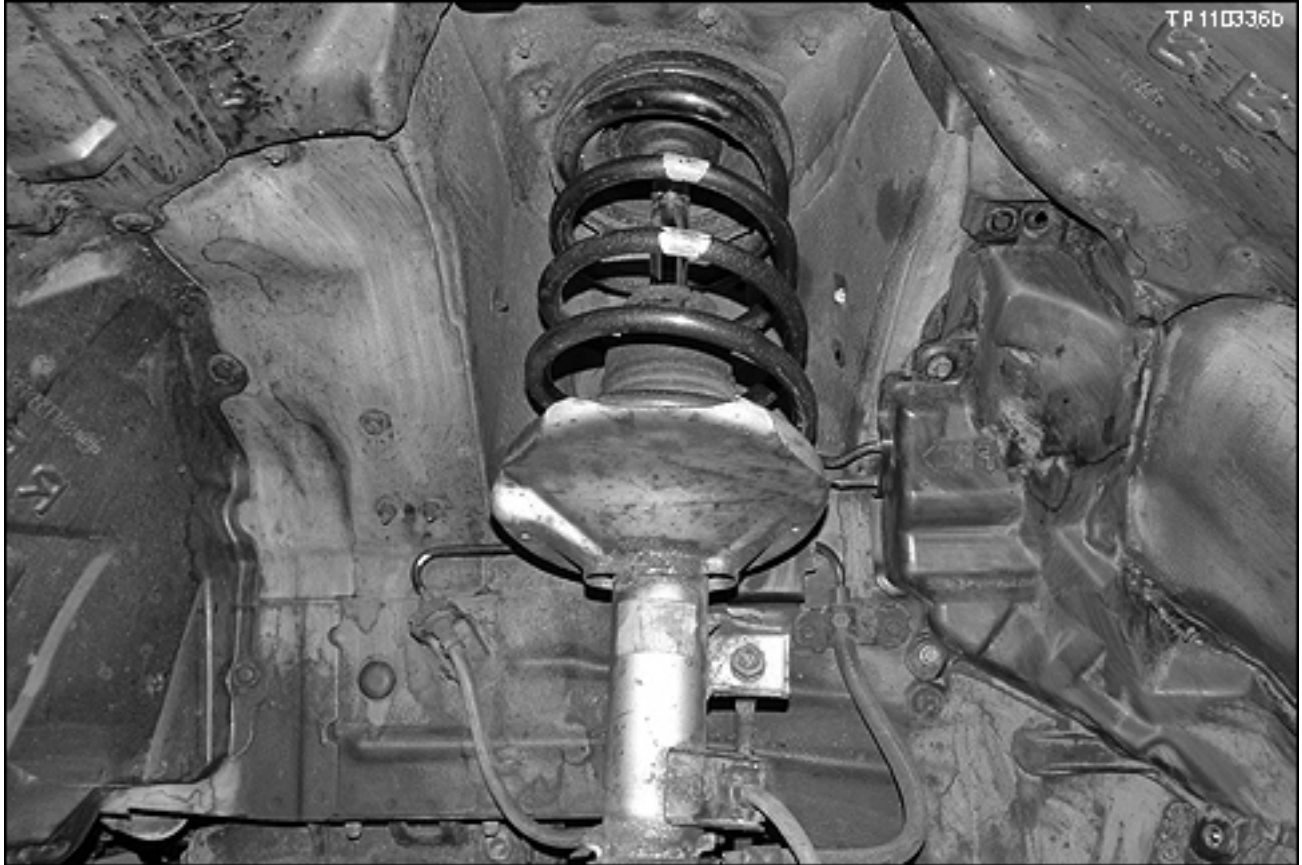
Figure B

No significant rust found on the panels.
