ITB11-041

August 11, 2011

**VOLUNTARY SERVICE CAMPAIGN  
1997- 2003 QX4 IN NON SALT STATES  
LEFT FRONT STRUT HOUSING CORROSION**

CAMPAIGN ID #: R1110  
NHTSA #: 11V-244  
APPLIED VEHICLES: 1997- 2003 QX4 (JR50)

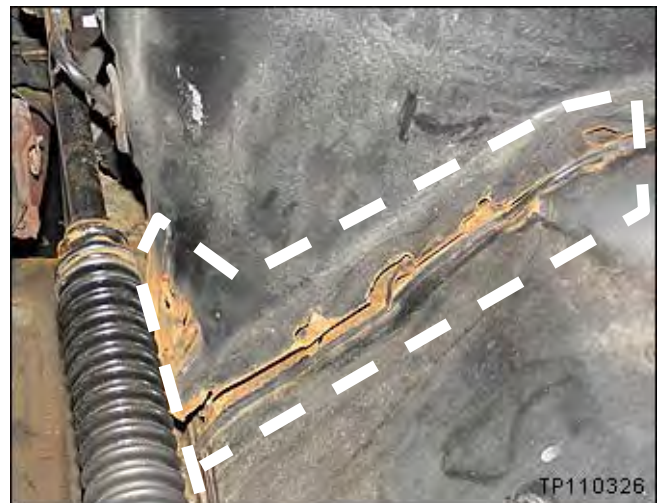
Figure RB5

7. Only if the strut housing panel is separated as show in Figure RB5:

Use a wire brush to clean any loose rust, paint, or other debris from the area shown with dashed line.
