ITB11-041d

June 8, 2012

**VOLUNTARY SERVICE CAMPAIGN  
1997-2003 QX4 IN NON SALT STATES  
LEFT FRONT STRUT HOUSING CORROSION**

CAMPAIGN ID #: R1110  
NHTSA #: 11V-244  
APPLIED VEHICLES: 1997- 2003 QX4 (JR50)

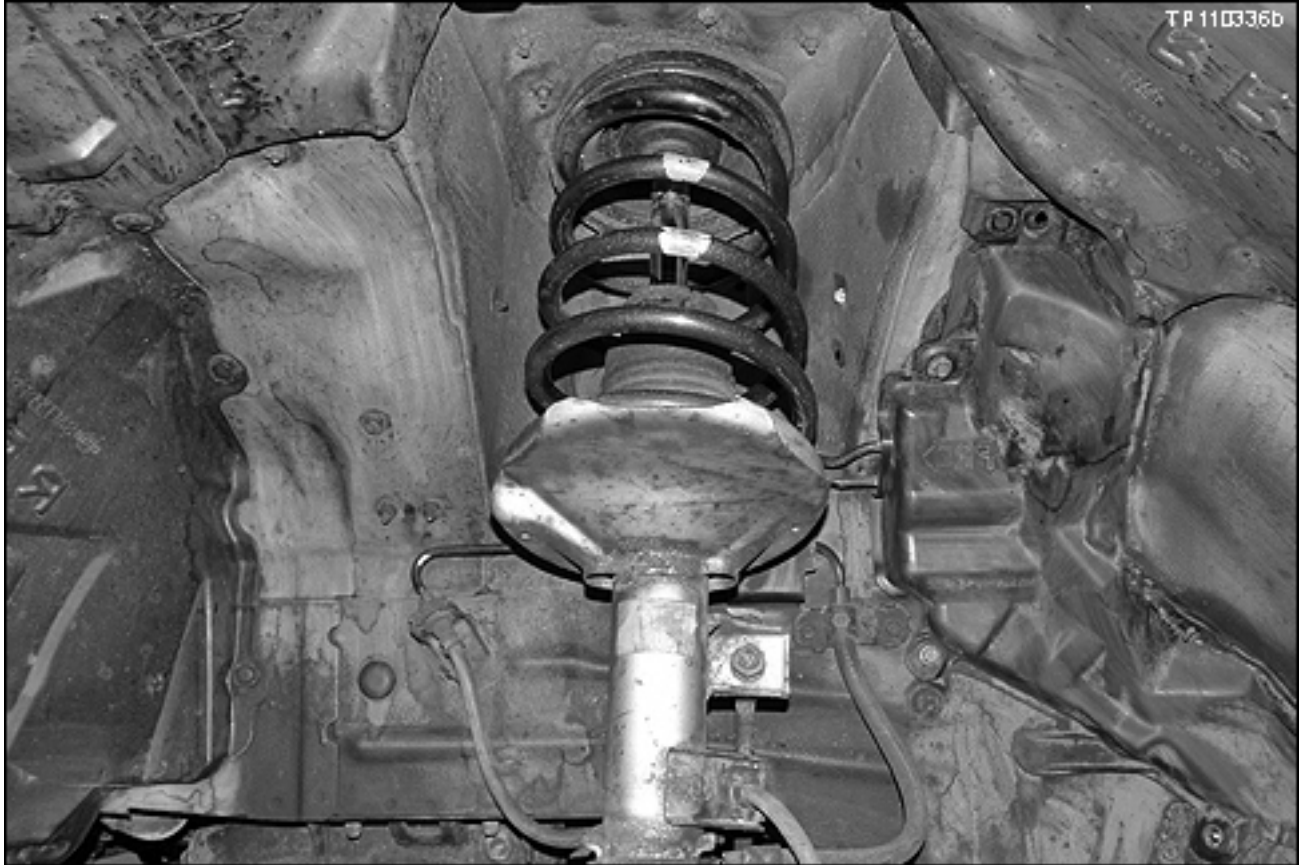
Figure B

4. Visually inspect for corrosion and rust on the wheel housing panels and the strut housing panels.

No significant rust found on the panels ON BOTH SIDES.

Significant rust is found on the panels ON ONE OR BOTH SIDES:

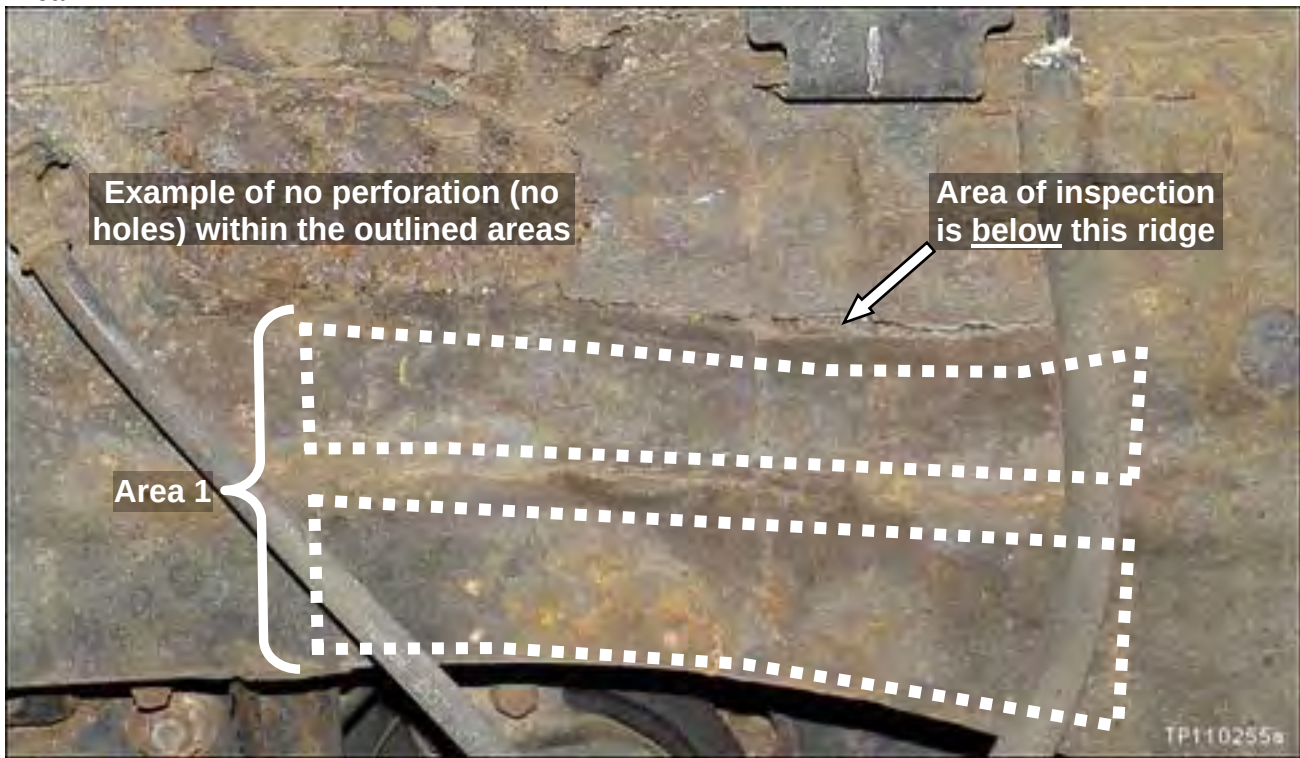
Figure 4

Area 1: Look for perforation (holes) in the metal only in the areas outlined above.

- a. Retain the vehicle at the dealer. (The vehicle is not repairable.)
- b. Supply the customer with a rental car.
- c. Fax a completed Non-Repairable Report to Morley (see page 56).

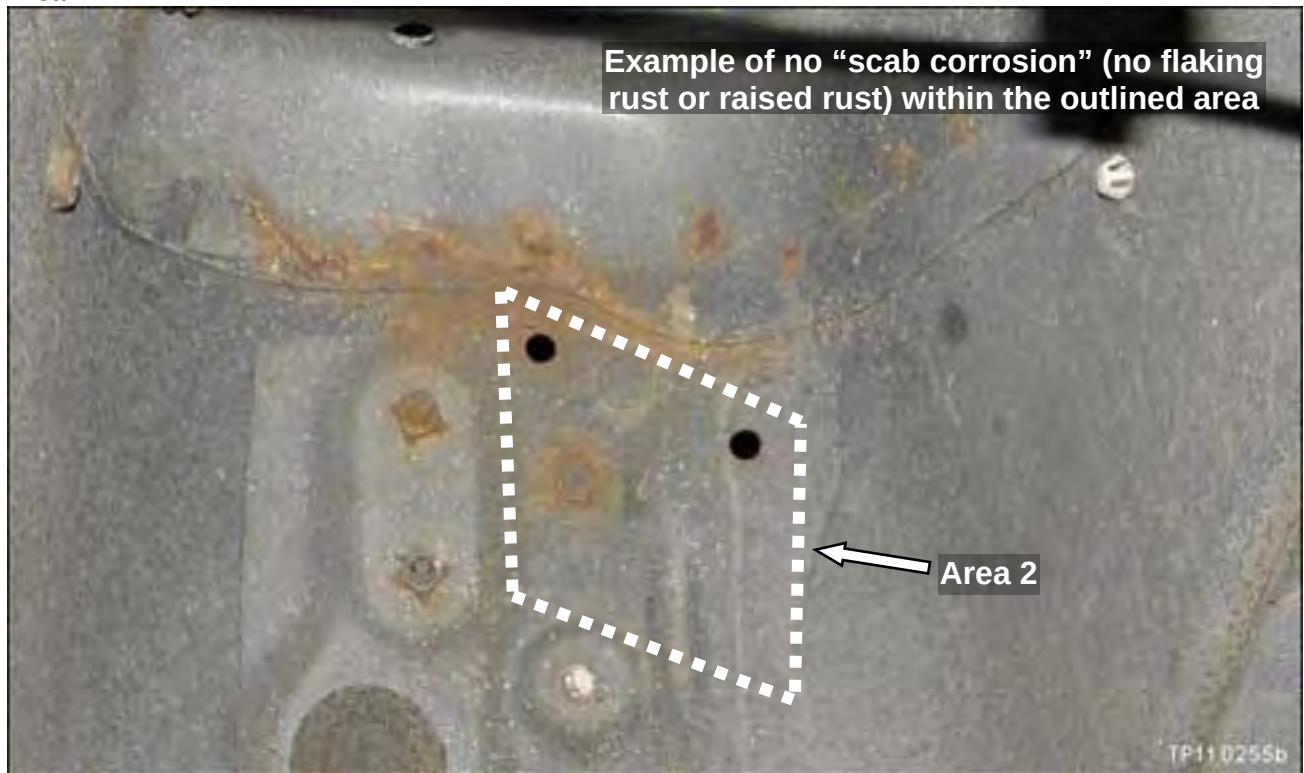
Figure 5

Area 2: Look for “scab corrosion” (flaking rust or raised rust) only in the area outlined above.

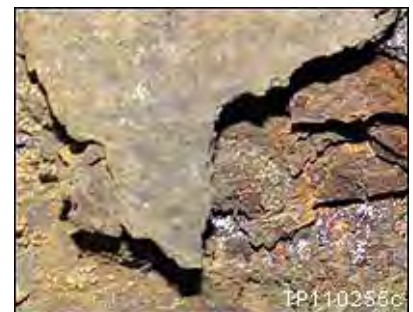
Figure 6 is an example of “scab corrosion” (flaking and raised rust).

If there is scab corrosion (flaking or raised rust) in Area 2 on the driver side OR passenger side:

- a. Retain the vehicle at the dealer. (The vehicle is not repairable.)
- b. Supply the customer with a rental car.
- c. Fax a completed Non-Repairable Report to Morley (see page 56).
