## SB-10040905-4360 Technical Bulletin

NTB11-066d June 8, 2012

## VOLUNTARY SERVICE CAMPAIGN 1996-2004 PATHFINDER IN NON SALT STATES FRONT STRUT HOUSING CORROSION

**CAMPAIGN ID #**: R1108 **NHTSA #**: 11V-244

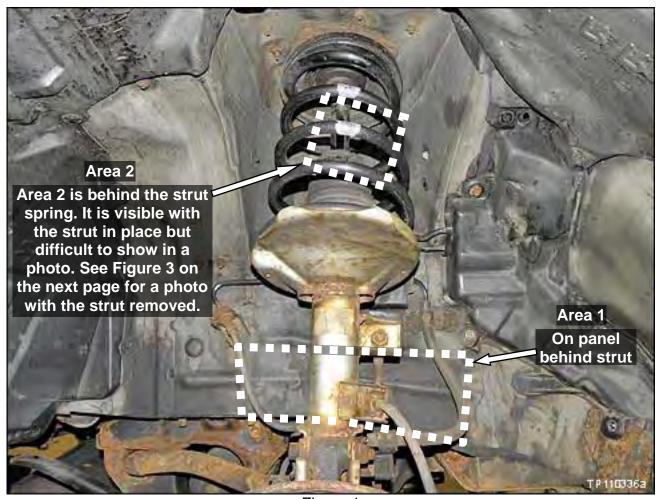
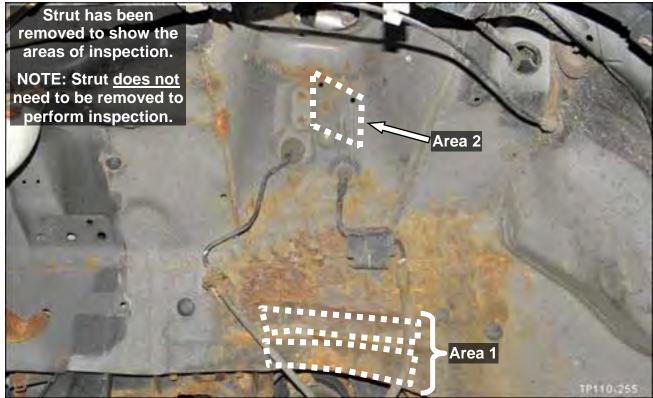
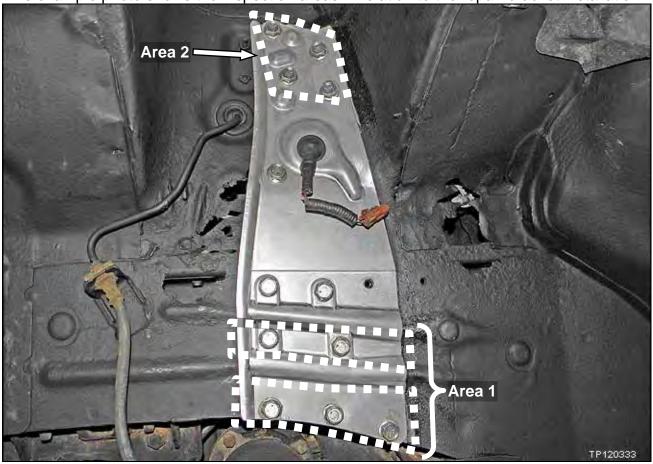
- 1. Lift the vehicle on a hoist.
- 2. Remove both front wheels.
- 3. Inspect for corrosion ON BOTH SIDES in the strut housing Area 1 and wheel house Area 2 (see Figures 1 through 4).

This example photo shows the inspection areas in relation to the repair bracket installation.

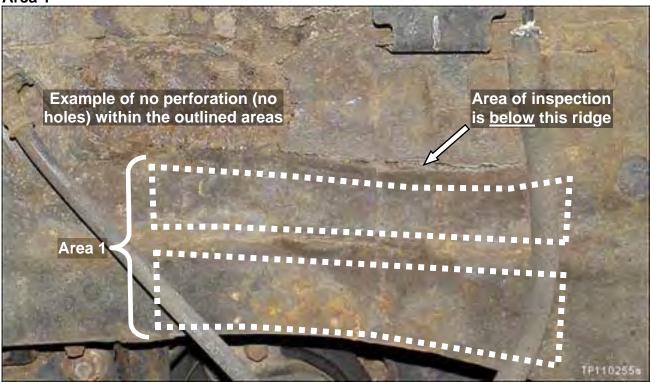
Figure 4

Area 1: Look for perforation (holes) in the metal only in the areas outlined above.

- a. Retain the vehicle at the dealer. (The vehicle is not repairable.)
- b. Supply the customer with a rental car.
- c. Fax a completed Non-Repairable Report to Morley (see page 56).

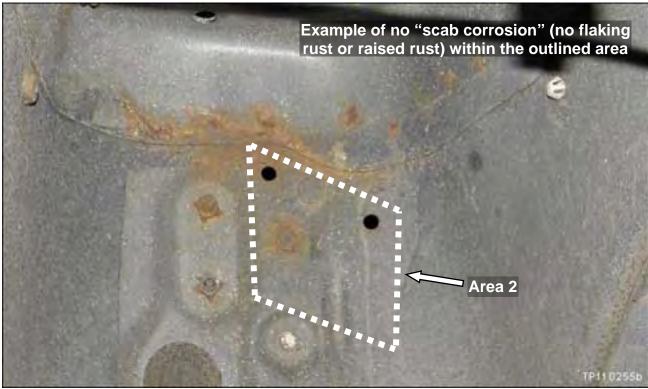
**Area 2:** Look for "scab corrosion" (flaking rust or raised rust) **only in the area outlined above**.

Figure 5 is an example of "scab corrosion" (flaking and raised rust).

- a. Retain the vehicle at the dealer. (The vehicle is not repairable.)
- b. Supply the customer with a rental car.
- c. Fax a completed Non-Repairable Report to Morley (see page 56).

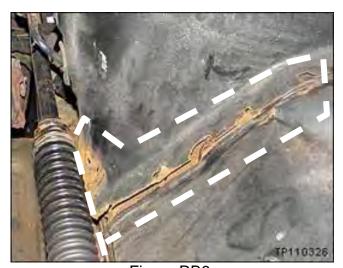
Figure RB6

- 7. Passenger side as needed: Remove the battery, Relay box-2, etc, to access the strut tower for inspection of separation.
- 7a. Only if the strut housing panel is separated as shown in Figure RB6:

Use a wire brush to clean any loose rust, paint, or other debris from the area shown with dashed line.
