## SB-10041407-5638

SI B12 16 11  
Engine Electrical Systems

**N55 Engine Failsafe - FC 120308 Boost Pressure Control, Plausibility: Pressure Too Low Stored in DME Fault Memory**

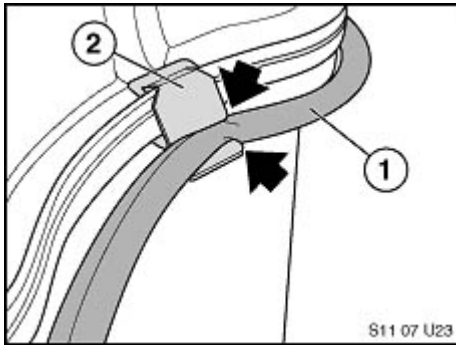
- Perform a quick inspection of all turbocharger boost control vacuum hoses; a slightly collapsed vacuum hose could lead to intermittent boost faults, or boost faults occurring only under heavy acceleration demands.

| | <ol style="list-style-type: none"> <li>1. Restricted vacuum hose</li> <li>2. Retaining clip</li> </ol> |

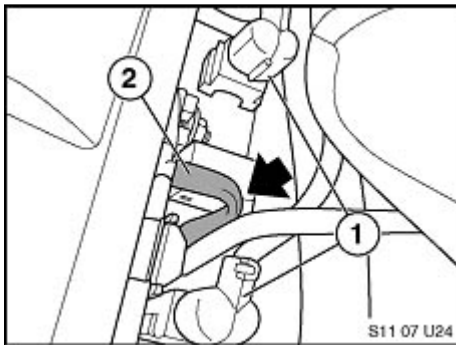
1. Vacuum solenoid
2. Kinked or restricted vacuum supply hose

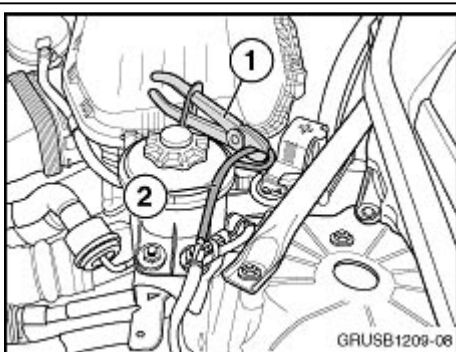
1. Suitable tool used to block the supply hose
2. Vacuum supply hose for the exhaust flap solenoid

- Using a vacuum gauge can be very helpful in diagnosing a vehicle with intermittent boost faults. Although the problem may not be present long enough to set a boost fault, the gauge may show a hint of a deteriorating vacuum level that could ultimately lead to an effective repair. Connecting the vacuum gauge at the vacuum actuator with a “tee” connection will determine the integrity of the vacuum supply (compare values to the attachment). Erratic operation of the vacuum gauge is a hint that a control problem is present; comparing the gauge movement to another vehicle will help determine whether a problem is present.
- On models equipped with an exhaust flap, isolate or disconnect the vacuum supply to the exhaust flap to eliminate a leaking or a defective vacuum solenoid. This can be done very easily by blocking the hose located near the right front strut tower.
