**SB-10041407-5981**

SI B12 16 11  
Engine Electrical Systems

**N55 Engine Failsafe - FC 120308 Boost Pressure Control, Plausibility: Pressure Too Low Stored in DME Fault Memory**

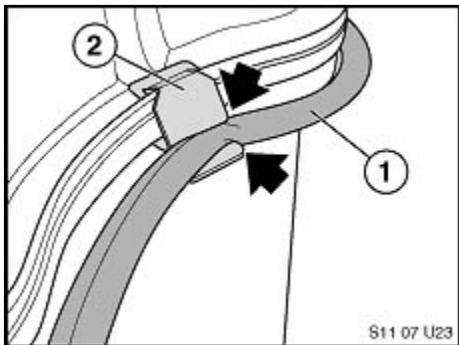
- Perform a quick inspection of all turbocharger boost control vacuum hoses; a slightly collapsed vacuum hose could lead to intermittent boost faults, or boost faults occurring only under heavy acceleration demands.

1. Restricted vacuum hose
2. Retaining clip

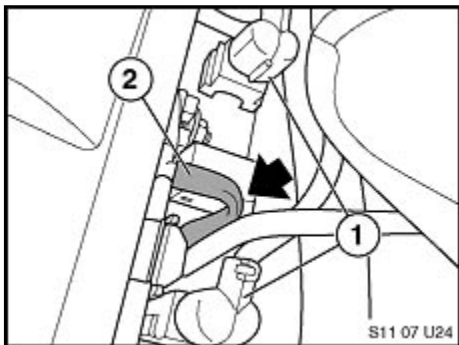
1. Vacuum solenoid
2. Kinked or restricted vacuum supply hose

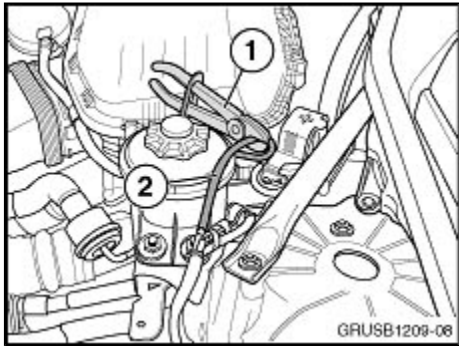
- Using a vacuum gauge can be very helpful in diagnosing a vehicle with intermittent boost faults. Although the problem may not be present long enough to set a boost fault, the gauge may show a hint of a deteriorating vacuum level that could ultimately lead to an effective repair. Connecting the vacuum gauge at the vacuum actuator with a “tee” connection will determine the integrity of the vacuum supply (compare values to the attachment). Erratic operation of the vacuum gauge is a hint that a control problem is present; comparing the gauge movement to another vehicle will help determine whether a problem is present.
- On models equipped with an exhaust flap, isolate or disconnect the vacuum supply to the exhaust flap to eliminate a leaking or a defective vacuum solenoid. This can be done very easily by

blocking the hose located near the right front strut tower.

1. Suitable tool used to block the supply hose
2. Vacuum supply hose for the exhaust flap solenoid
