# TECHNICAL BULLETIN

LTB00304NAS7

### Fuel Gauge Operation / DTC U0128-00 Stored

LR4 (L319)

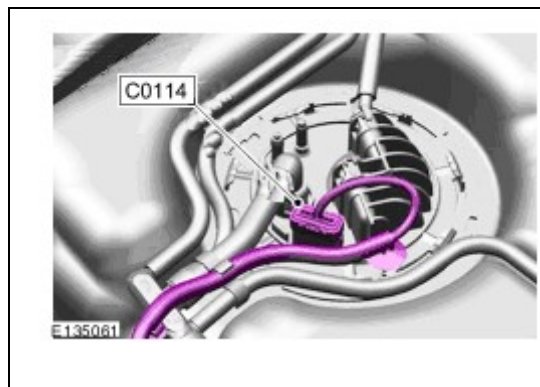
**Cause:** 1) Software issue within the instrument cluster (DTC U0128-00); 2) Fretting corrosion across the fuel sender harness pins inside the fuel tank (black connectors) or possible backed out pins in any of the following areas, internal to the fuel tank (sender wiring), fuel pump module and/or flange assembly.

14. The first area to check before commencing any further work is the vehicle harness to fuel tank connection. A poor connection may exist where the harness plugs into the flange (see E135061). To test, with the ignition turned off and connector in place, pull the connector upwards to give a worst case scenario connection situation. Turn on the ignition, does the gauge drop to zero, repeat several times. If fault is found, remove connector and ensure pin connections are not loose and that they are correctly retained in the connector housing. If no fault can be found confirm the connector is fitted and pushed fully home and continue with further diagnostics as detailed TOPIx section 310-01.

**Action:** Should a customer express concern, check if DTC U0128-00 is stored and carry out the download to the instrument cluster if required. If DTC U0128-00 is not stored the first area to check before commencing any further work is the vehicle harness to fuel tank flange connection. Also check all connections for backed out pins.

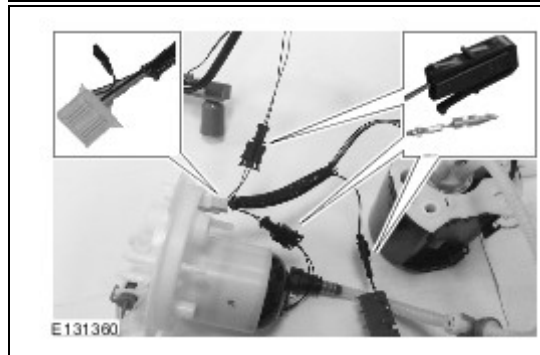
△ **NOTE: Not all derivatives will have the same number of connectors. Fuel tank module / sender components removed from fuel tank for clarity.**

- Backed out pin / wire could be any of the wires on the connector assembly(s); all must be checked.

16. If a failure to the harness or individual fuel sender cannot be verified at any point during the diagnostic stage, then both fuel level senders and the flange should be replaced to avoid the possibility of a repeat repair.
