Service Bulletin

Bulletin No.: PI0595A

Subject: Information on Floor Mat Retainer Orientation

Models: 2011-2013 Buick Enclave
2011-2013 Chevrolet Traverse
2011-2013 GMC Acadia

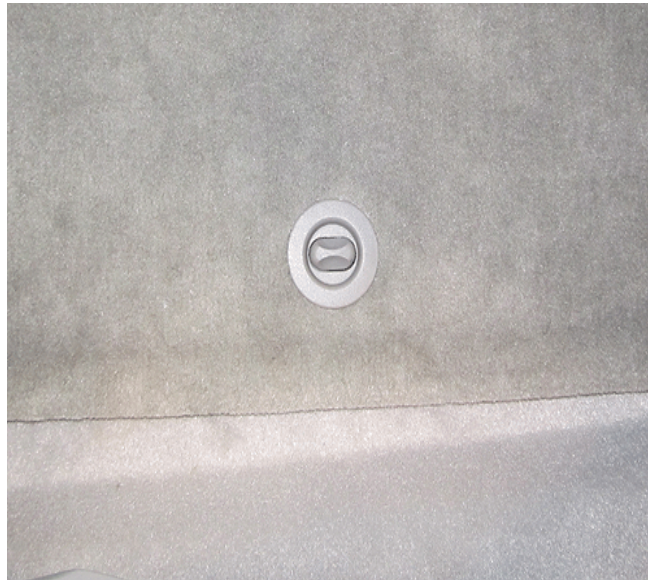
A technician or customer may comment that the floor mat(s) will not properly install, or engage with, the carpet side mat retainer. This condition could occur at any of the front or second row floor mat locations.

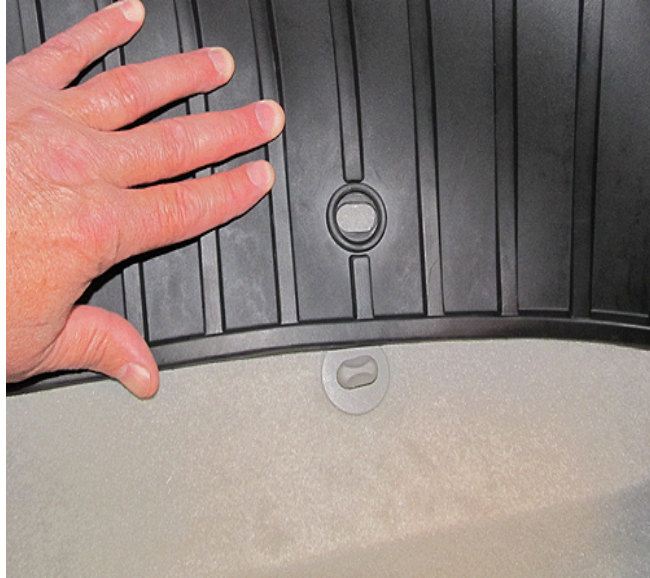
2730210

The opening on the floor mat is oriented for the carpet side quarter turn retainer to be in cross-car position when the mat is installed in the vehicle. Proper engagement of the floor mat is achieved when the retainer knob is rotated a quarter turn to the fore/aft position. If the orientation of the mat/retainer is not allowing proper engagement, the orientation of the carpet side retainer must be corrected.
