# Service Bulletin

Bulletin No.: PI0595

**Subject:** Information on Floor Mat Retainer Orientation

**Models:** 2011-2012 Buick Enclave  
2011-2012 Chevrolet Traverse  
2011-2012 GMC Acadia

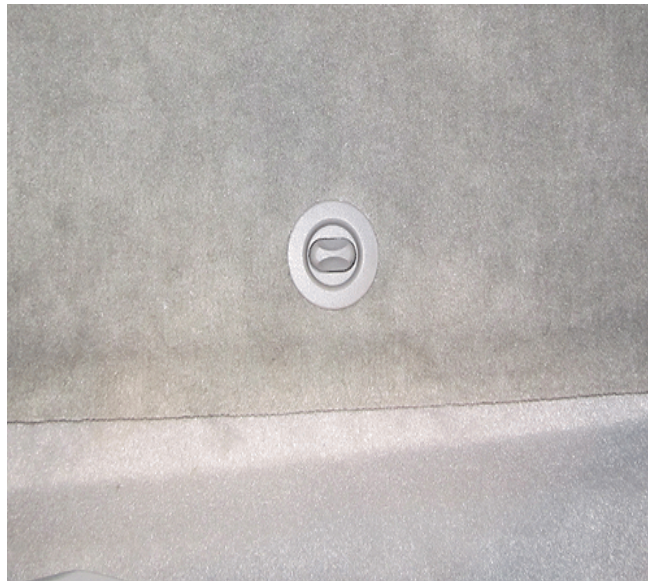
A technician or customer may comment that the floor mat(s) will not properly install, or engage with, the carpet side mat retainer. This condition could occur at any of the front or second row floor mat locations.
