SERVICE CAMPAIGN BULLETIN

NTB10-068e

VOLUNTARY SERVICE CAMPAIGN NISSAN NAVIGATION SOFTWARE UPDATE

CAMPAIGN ID #: P0337

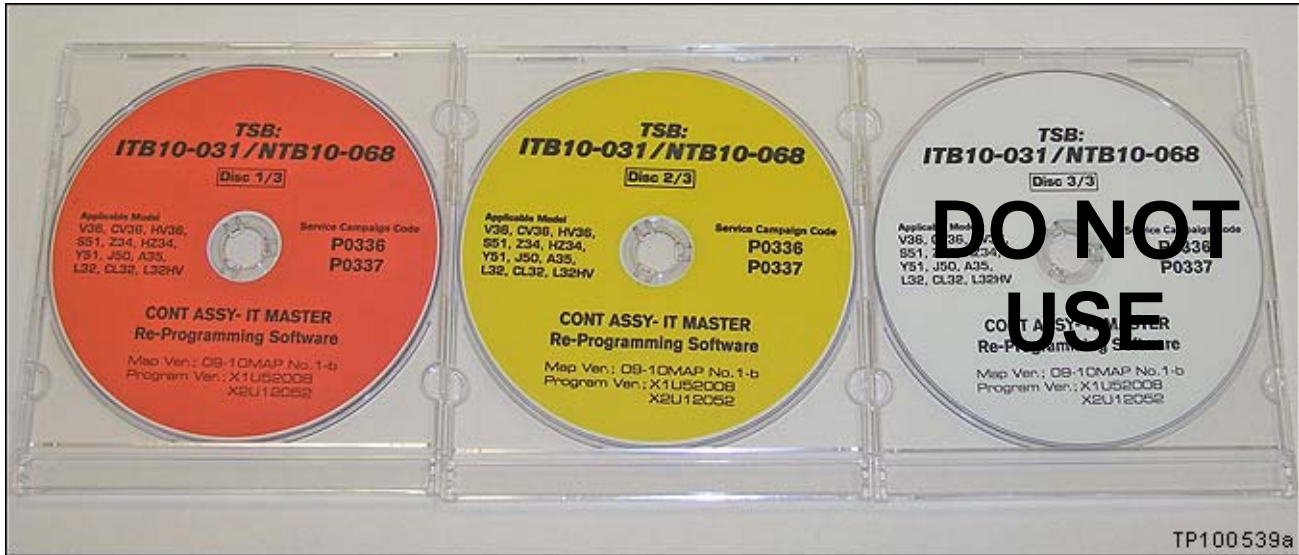
- Discs 1/3 and 2/3 of the set shown in Figure A are used for all applied models in this campaign except GT-R.
- Do not use disc 3/3.

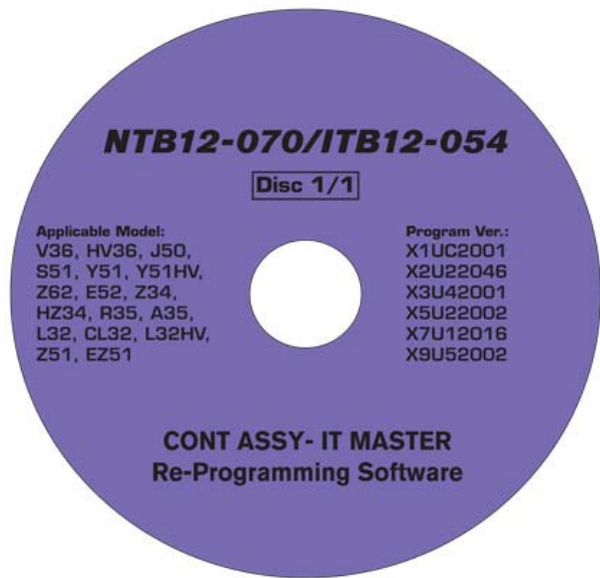
Figure B

- This **NEW** disc (Figure B) is required for all applied models in this campaign.
- This disc replaces disc 3/3 above.
- This disc also replaces disc NTB10-125b/ITB10-066b (disc 1/1) and disc NTB10-068 (disc1/1) for GT-R.

NOTE: Numbers on these discs do not match this bulletin's reference number or the campaign ID #.

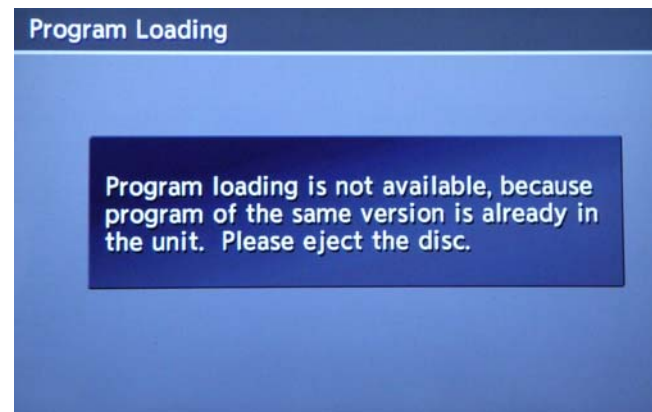
Figure13

- If the screen in Figure 13 is displayed, this disc is not needed.
 - Remove/eject the DVD from the CD slot.
 - Go to **C: Check Bluetooth® Setting** on page 12.

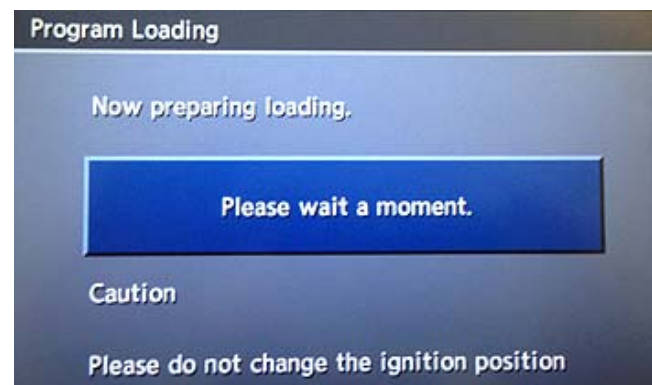
- If “Now preparing loading” shown in Figure 14 is displayed, reprogramming will begin automatically.
 - Follow the on-screen Caution during the reprogram.

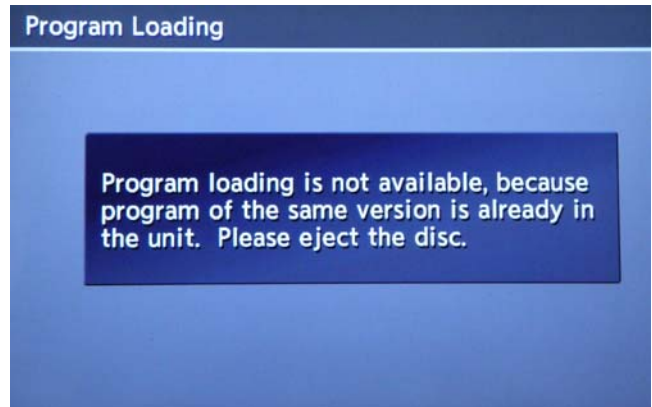
- If Figure 23 is displayed, it indicates that the reprogram has been completed.
 - If complete, go to step 26.
