SERVICE CAMPAIGN BULLETIN

NTB10-068d

VOLUNTARY SERVICE CAMPAIGN NISSAN NAVIGATION SOFTWARE UPDATE

CAMPAIGN ID #: P0337

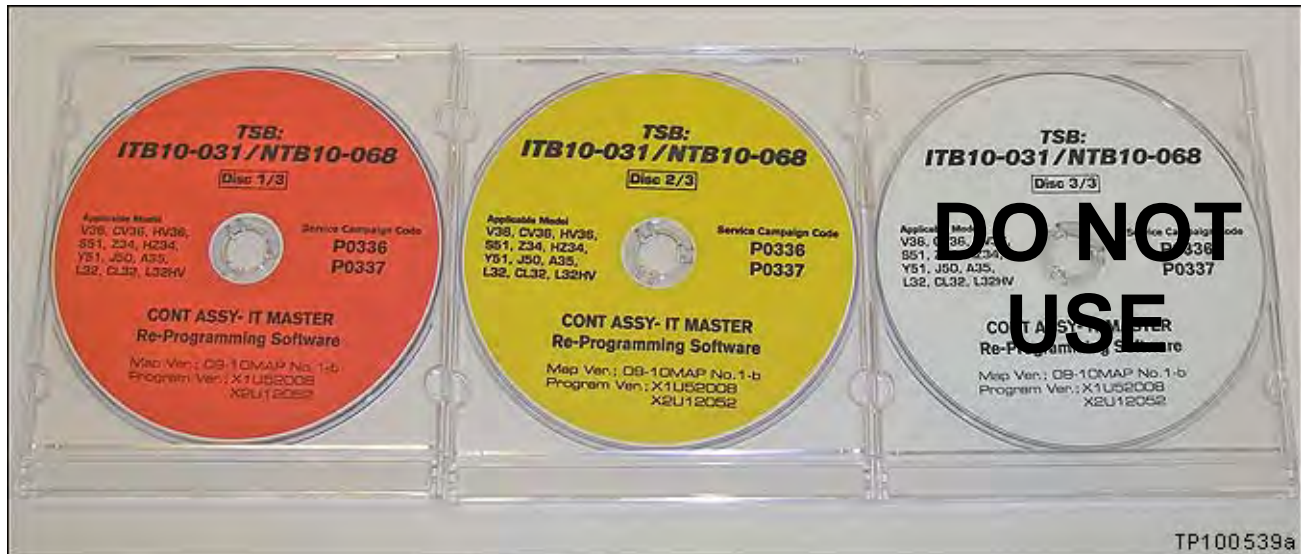
- Discs 1/3 and 2/3 of the set shown in Figure A are used for all applied models in this campaign except GT-R.
- Do not use disc 3/3.

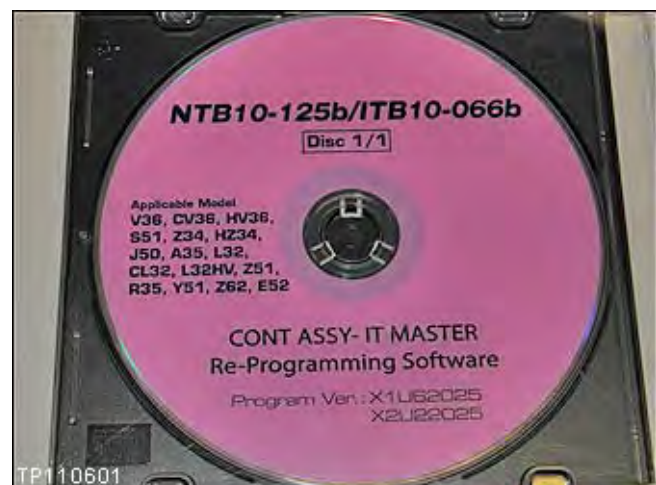
Figure B

- This disc (Figure B) is required for all applied models in this campaign.
- This disc replaces disc 3/3 above.
- This disc also replaces disc NTB10-068 (disc1/1) for GT-R.

NOTE: Numbers on this disc do not match this bulletins reference number or the campaign ID #.

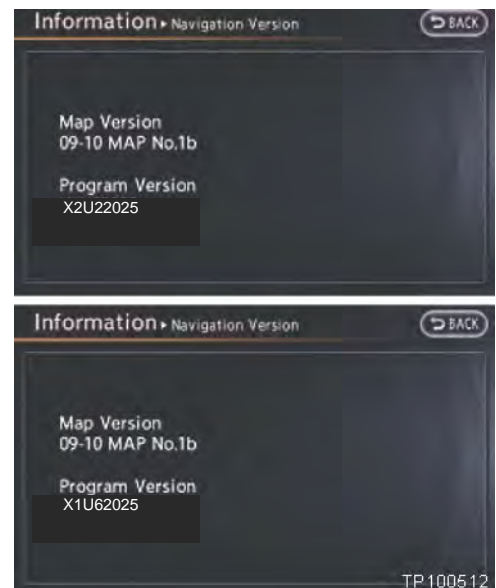
Figure 16

c. Map Version should be **09-10 MAP No.1b**.

d. Program Version should be:

X2U22025 or X1U62025

NOTE: If the Map Version or the Program version is different than above, go back to step 5 on page 6.

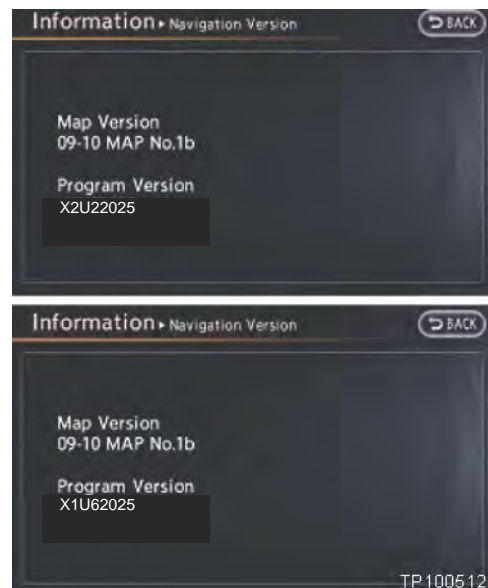
Figure 23

d. Program Version should be:

X2U22025 or X1U62025

NOTE: If the Program version is different than above, turn the ignition off, go back to step 5 on page 11 and load the disc again.
