Service Bulletin

SUBJECT: Special Coverage Adjustment - Shift Lever May Not Display Correct Gear

MODELS: 2007-2008 Saturn AURA
Equipped with 4-Speed Automatic Transmission (ME7/MN5)

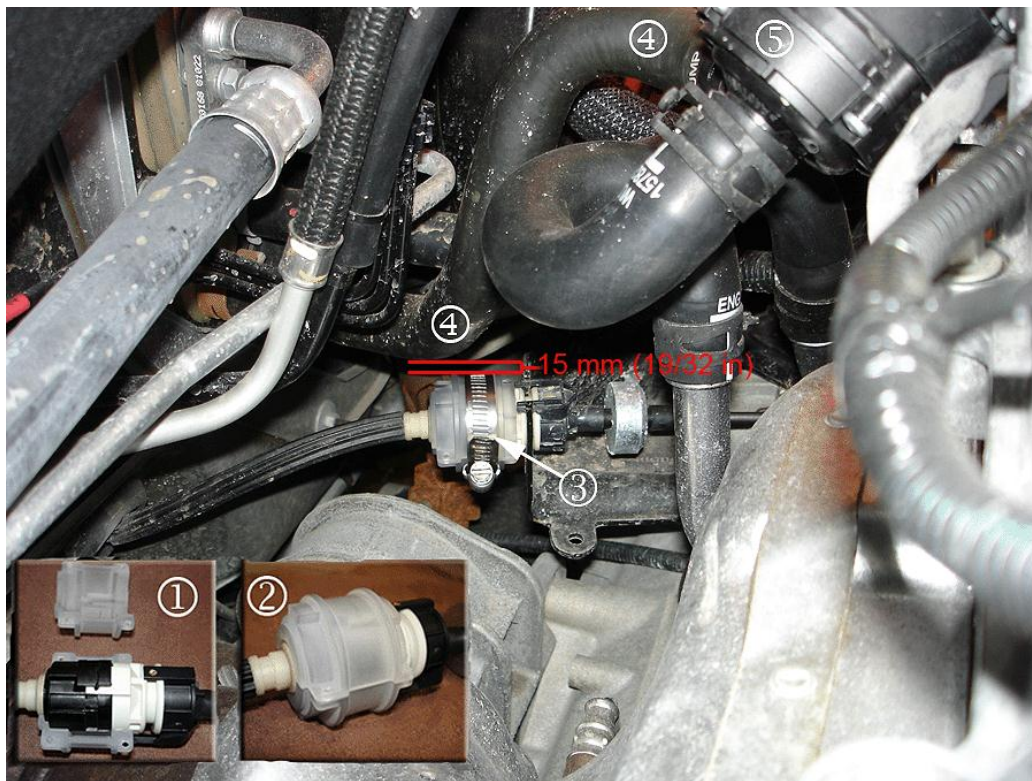
2269484

Hybrid vehicle shown. Combustion engine vehicle is similar.

- (1) Clam Shell in Two Pieces
- (2) Clam Shell Around Shift Cable Locking Tabs
- (3) Clamp on Clam Shell
- (4) Inlet Coolant Hose and
- (5) Heater Cooler Pump.

5. Install the clam shell (1) (2) over the shifter cable locking tabs.
6. Install the service clamp over the clam shell (3). Position the clamp fastener head away from the inlet coolant hose (4). **Tighten the clamp to 4 N·m (35 lb-in).**
7. Ensure that there is 15 mm (19/32 in) of clearance between the inlet coolant hose (4) and the clam shell (3). On hybrid equipped vehicles, it may be necessary to reposition the inlet coolant hose (4) to achieve the required 15 mm (19/32 in) of clearance. **To reposition the inlet coolant hose (4) on hybrid equipped vehicles, locate the heater cooler pump (5) and perform Steps 5.1-5.4.**

Caution: Do not kink or damage the inlet coolant hose (4) when repositioning the hose to obtain the 15 mm (19/32 in) clearance. To avoid damaging the hose clamp, use J-38185 or equivalent hose clamp pliers to loosen the hose clamp.
