Service Bulletin

SB-10042987-8678

SUBJECT: Special Coverage Adjustment - Shift Lever May Not Display Correct Gear

**MODELS: 2007-2008 Saturn AURA
Equipped with 4-Speed Automatic Transmission (ME7/MN5)**

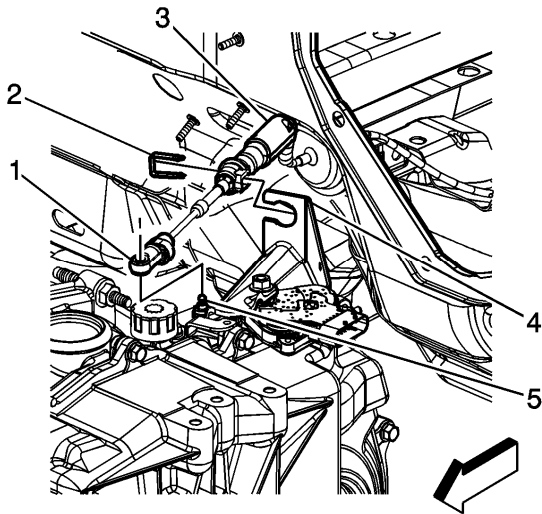
1765068

Some 2007-2008 model year Saturn AURA vehicles equipped with a 4-speed automatic transmission (ME7/MN5) have a condition in which the transmission shift cable may fracture. As the fracture begins, the driver may have a difficult time selecting a gear or removing the key from the ignition. If these warnings are ignored, the cable could continue to fracture and shift function could be lost. The driver may not be able to restart the vehicle or shift the vehicle into PARK, allowing the vehicle to roll away if the driver has exited the vehicle without applying the park brake.

- Remove and discard the cable bracket (4).
- Install a new floor shift control cable and new bracket. Refer to *Floor Shift Control Cable Replacement* in SI
