# Service Bulletin

Bulletin No.: PI0631A

**Subject:** Malfunction Indicator Lamp (MIL) On, Various DTCs Set Including P0641 and/or P06A3, IPC Inoperative, Display Fuse Blown

**Models:** 2012 Chevrolet Impala  
Vehicles without RPO NU6 Emissions  
Built Prior to December 1, 2011

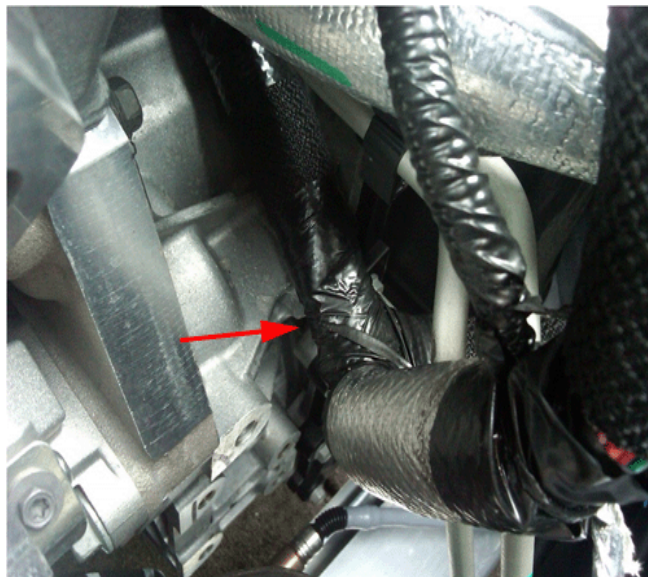
2743910

This condition may be caused by the engine wiring harness rubbing on the front right side of the transmission. The engine harness may have chafing or damage to the wires. Contact with the edge of the transmission may result in a rub-through of the wires within that harness.

If necessary, peel the tape from the area and look for ANY damaged wires. Repair the harness as necessary. Refer to Wiring Repairs in SI.

Wrap harness conduit around the affected area of the harness and tie strap to the transmission cooler line bracket.
