Service Bulletin

Bulletin No.: PI0631

Subject: Engine Wiring Harness Rubbing on Transmission, Various DTCs Set, Malfunction Indicator Lamp On

Models: 2012 Chevrolet Impala
Vehicles without RPO NU6 Emissions
Built Prior to December 1, 2011

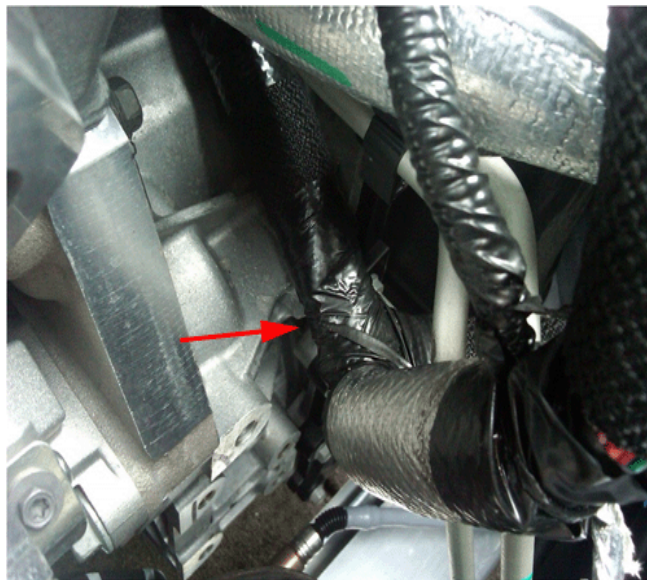
2743910

This condition may be caused by the engine wiring harness rubbing on the front right side of the transmission. The engine harness may have chafing or damage to the wires. Contact with the edge of the transmission may result in a rub-through of the wires within that harness.

If necessary, peel the tape from the area and look for ANY damaged wires. Repair the harness as necessary. Refer to Wiring Repairs in SI.

Wrap harness conduit around the affected area of the harness and tie strap to the transmission cooler line bracket. If chafing is not observed, refer to the appropriate diagnostic procedures in SI.
