Service Bulletin

PRELIMINARY INFORMATION

Subject: Intermittent No Crank No Communication To High Speed LAN Modules

Models: 2010 - 2012 Chevrolet Camaro

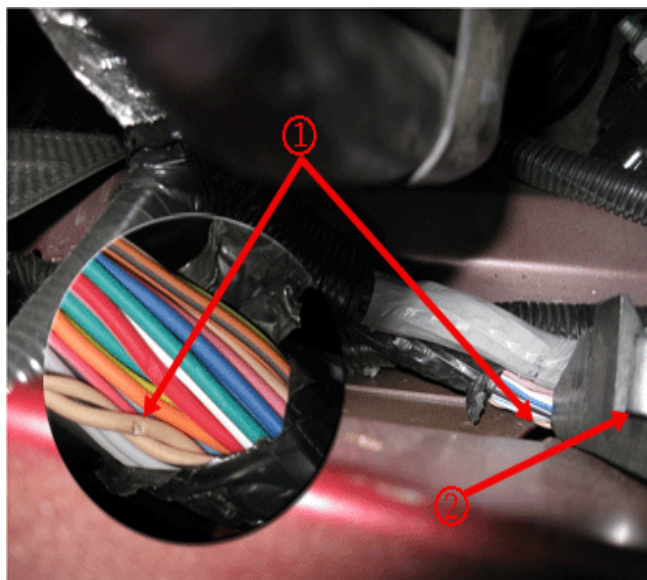
2503475

In rare cases a customer may report an intermittent fluctuation of IP gauges, no crank, SES light on, various IP warning indicators and messages, or no communication to various High Speed LAN modules. Communication to control modules may be random and could change during inspection of the vehicle. Any of these concerns could be caused by a short to ground on either of the two High Speed LAN circuits 2500 and/or 2501.

Inspect the engine wiring harness (1) under the ECM (2) for possible chaffing on the inner fender panel.

Repair the wiring, install conduit on this area of the harness and relocate the harness away from the panel to protect it from future damage.
