Bulletin No.: PI0686A

Service Bulletin

Subject: Front Seat Lateral Movement, Clunk, Squeak, Click Noise or Shift While Cornering

Models: 2012-2014 Buick Verano
2011-2014 Chevrolet Cruze
Equipped with RPO A53, ADS, AH4 6-Way Power or 6-Way Manual Driver or Passenger Seat

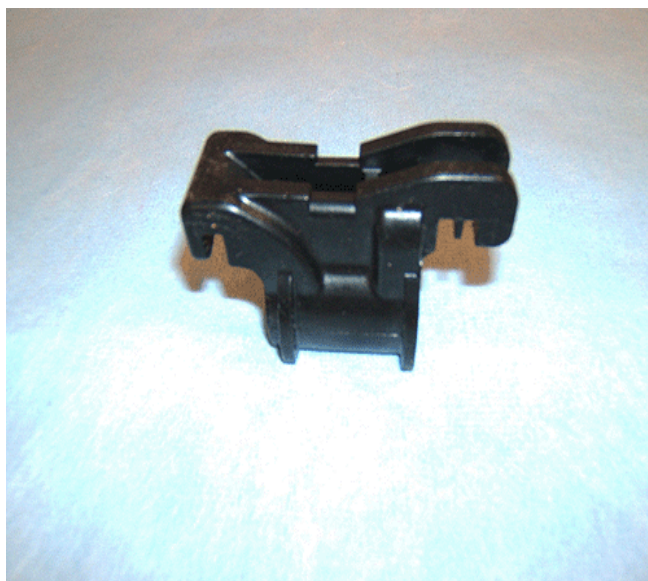
Some customers may comment on a lateral movement in the seat while cornering. This condition has also been described as a clunk, squeak, click noise or shift in the seat. This condition occurs on the driver side 6-way manual or power adjusted seat. This condition may also be present on the passenger side seat if the vehicle is equipped with a 6-way adjustable passenger seat.

This condition may be caused by movement between the seat pan and the seat cross tube.

A clip has been made available to eliminate the lateral seat movement. Use the following steps to install the clip to the driver side seat. If the vehicle is equipped with a 6-way adjustable passenger seat, repeat the procedure on the passenger seat.
