Service Bulletin

Bulletin No.: 12-02-32-001

Subject: Hydraulic Power Steering Leak at Hose Connection to Steering Rack

Models: 2007-2012 Cadillac Escalade, Escalade ESV, Escalade EXT
2007-2012 Chevrolet Avalanche, Silverado, Suburban, Tahoe
2007-2012 GMC Sierra, Yukon, Yukon XL, Yukon Denali, Yukon XL Denali

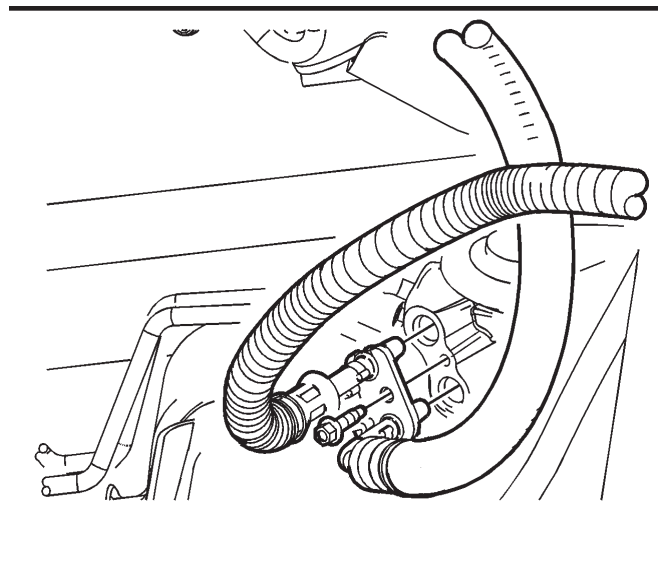
2760840

Some customers may comment on a fluid leak under the front of the vehicle. Upon further investigation, the technician may find fluid leaking from the power steering hose connection at the rack.

Based on parts returned to the Warranty Parts Center (WPC), replacement of both hose-to-rack "duckbill type" seals has corrected the condition. Replacement of the rack is not necessary for this issue.
