Service Bulletin

Bulletin No.: 12-02-32-001A

Subject: Hydraulic Power Steering Leak at Hose Connection to Steering Rack

Models: 2007-2013 Cadillac Escalade Models
2007-2013 Chevrolet Avalanche, Silverado, Suburban, Tahoe
2007-2013 GMC Sierra, Yukon Models

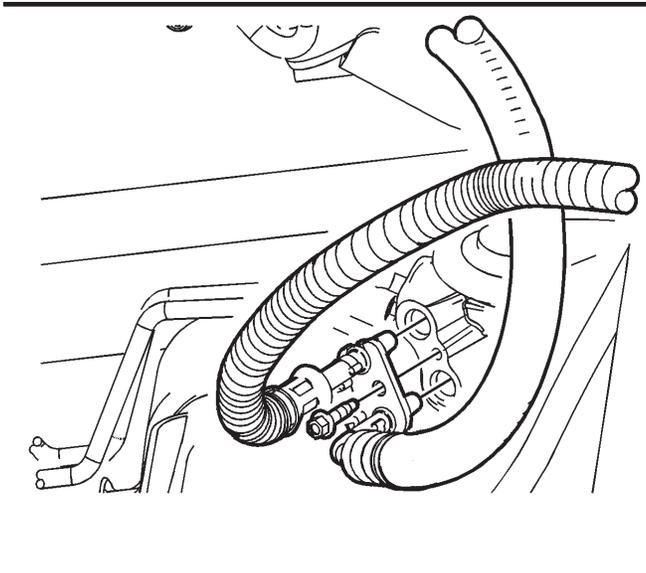
2760840

Some customers may comment on a fluid leak under the front of the vehicle. Upon further investigation, the technician may find fluid leaking from the power steering hose connection at the rack.

Based on parts returned to the Warranty Parts Center (WPC), replacement of both hose-to-rack “duckbill type” seals has corrected the condition. Replacement of the rack is not necessary for this issue.
