# Service Bulletin

Bulletin No.: PI0639A

**Subject:** Service StabiliTrak Message Displayed in DIC, StabiliTrak Indicator Light On, DTC C0455 and/or C0710 Set

**Models:** 2007-2012 Cadillac Escalade, Escalade ESV, Escalade EXT  
2007-2012 Chevrolet Avalanche, Colorado, Silverado, Suburban, Tahoe  
2008-2012 Chevrolet Express  
2007-2012 GMC Canyon, Sierra, Yukon, Yukon Denali, Yukon XL, Yukon Denali XL  
2008-2012 GMC Savana

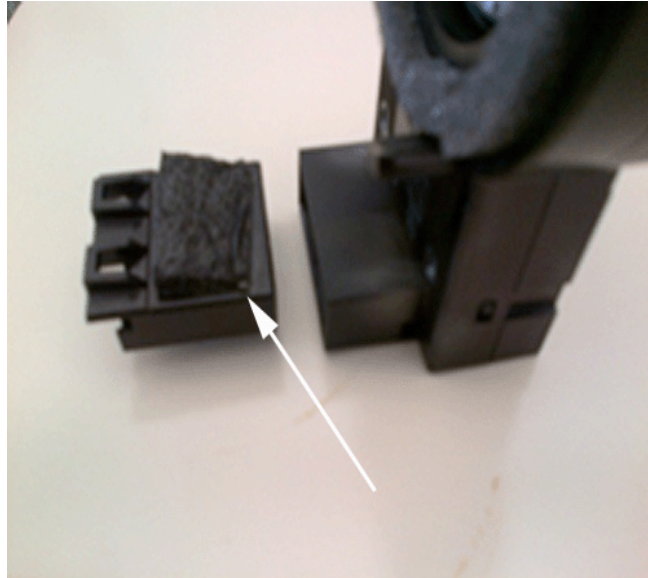
2808092

This condition may be caused by an increase in resistance in the circuits connecting the steering position sensor and the EBCM due to fretting corrosion on the connector terminals.

Also, the male to female plastic connector may have excessive clearance that can cause the connector to move up and down.

2. Add a piece of Adhesive Back Shim Stock the width of the connector to the flat surface on the male connector. This provides support to the connector to keep it from moving up and down.
