Service Bulletin

Bulletin No.: PI0639B

Date: May, 2013

Subject: Service StabiliTrak Message Displayed in DIC, StabiliTrak Indicator Light On, DTC C0455 and/or C0710 Set

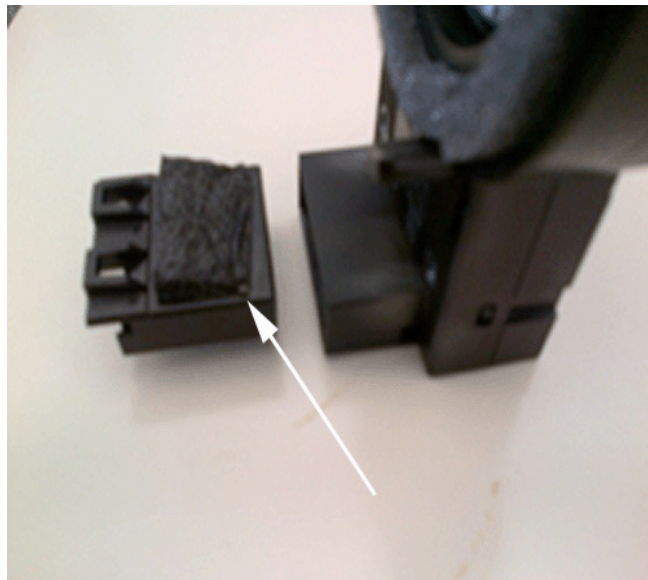
2808092

This condition may be caused by an increase in resistance in the circuits connecting the steering position sensor and the EBCM due to fretting corrosion on the connector terminals.

Also, the male to female plastic connector may have excessive clearance that can cause the connector to move up and down.

1. Disconnect the steering wheel position sensor connector.

2. Add a piece of Adhesive Back Shim Stock the width of the connector to the flat surface on the male connector. This provides support to the connector to keep it from moving up and down.
