## Service Bulletin

Bulletin No.: PI0639B

**Subject:** Service StabiliTrak Message Displayed in DIC, StabiliTrak Indicator Light On, DTC C0455 and/or C0710 Set

**Models:** 2007-2013 Cadillac Escalade Models  
2007-2013 Chevrolet Avalanche, Colorado, Silverado, Suburban, Tahoe  
2008-2013 Chevrolet Express  
2007-2013 GMC Canyon, Sierra, Yukon Models  
2008-2013 GMC Savana  
All Built Prior to October 01, 2012

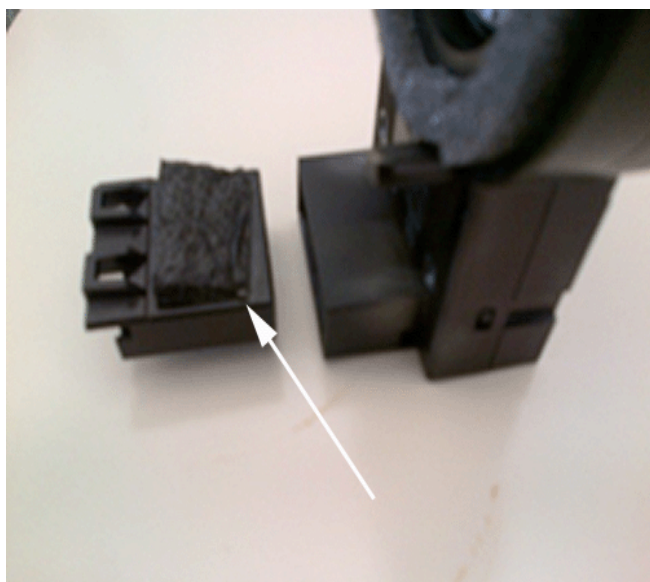
2808092

This condition may be caused by an increase in resistance in the circuits connecting the steering position sensor and the EBCM due to fretting corrosion on the connector terminals.

Also, the male to female plastic connector may have excessive clearance that can cause the connector to move up and down.

1. Disconnect the steering wheel position sensor connector.

2. Add a piece of Adhesive Back Shim Stock the width of the connector to the flat surface on the male connector. This provides support to the connector to keep it from moving up and down.
