SB-10044023-9053

SI B61 13 12
General Electrical Systems

100A Fuse in Rear Power Distribution Box Failed, Causing Electrical System Failure

F25 (X3)

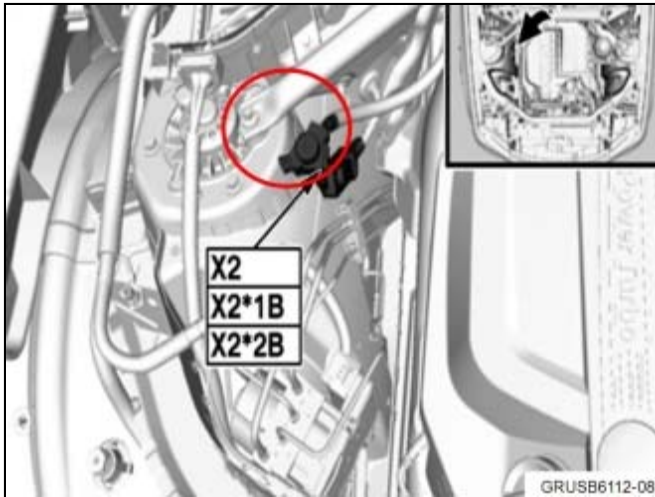
4. **X2 B+ Jump-starting point:**
Check the metal brace located

near the jump point terminal for signs of arcing. This can happen when jump-starting or the charging aid contacts the metal brace along with the terminal.

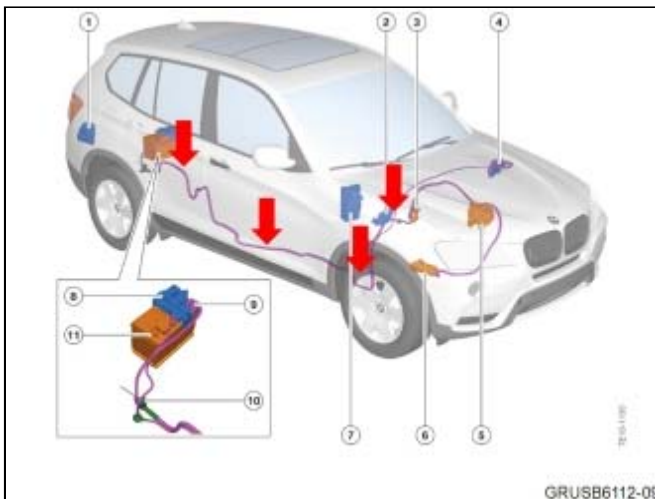
5. **B+ Battery cables that run under the vehicle:** Check the battery cables that run under the vehicle from the rear power distribution box up to the engine compartment for damage. This can be the result of underbody damage caused by an outside source. The diagram to the left shows the routing of the cable. If the cable is damaged, it needs to be replaced.
